# Access Compliance Report

## Public Rights-of-Way

### (Curb Ramps)

Intersection ID: 11627	Main Street: CARLYLE_DR	Cross Street: CARTWRIGHT_PL	Location: S
ADA ID: 0FBE19DAB118	Ramp Type: Perp	Initial Pass/Fail: Fail	Overall Compliance: No
		Severity Score: 10

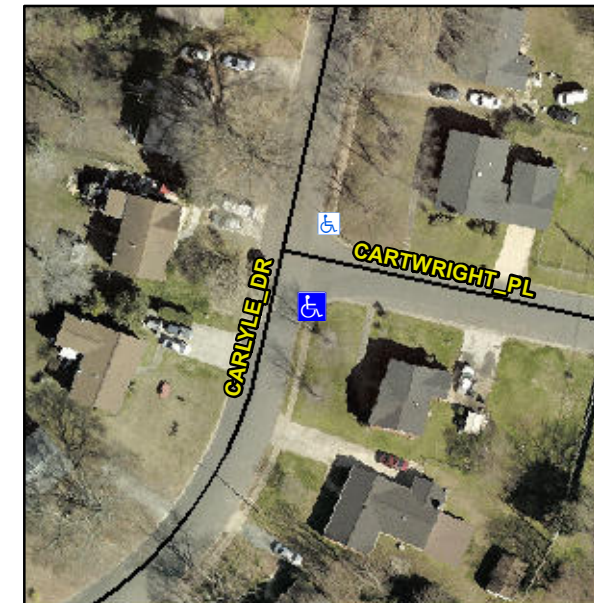
**Not Found, R304.5.1, R304.5.3**

Compliance	Description	Data	Compliance	Description	Data
N/A	Ramp Length (in)	28.5	Yes	Ramp Slope (%)	6.5
No	Ramp Width (in)	47.0	No	Ramp XSlope (%)	3.0
N/A	Flare Type LT	N/A	N/A	Flare Type RT	N/A
N/A	Flare Slope LT (%)	N/A	N/A	Flare Slope RT (%)	N/A
N/A	Flare Traversable LT?	N/A	N/A	Flare Traversable RT?	N/A
N/A	Landing Length (in)	N/A	N/A	DWS Provided?	N/A
N/A	Landing Width (in)	N/A	N/A	DWS Contrast?	N/A
N/A	Landing Slope (%)	N/A	N/A	DWS Length (in)	N/A
N/A	Landing X Slope (%)	N/A	N/A	DWS Full Width?	N/A
N/A	Landing Curb? (Y/N)	N/A	N/A	DWS Offset (in)	N/A
N/A	Shared Landing?	N/A			
N/A	Gutter Ponding?	N/A	N/A	Gutter Slope (%)	N/A
N/A	Gutter Lip Ht (in)	N/A	N/A	Gutter X Slope (%)	N/A
N/A	Painted X Walk1?	No	N/A	Painted X Walk2?	N/A
	X Walk 1 Direction	To N		X Walk 2 Direction	N/A
N/A	X Walk 1 Width (in)	N/A	N/A	X Walk 2 Width (in)	N/A
	X Walk 1 Slope (%)	0.0		X Walk 2 Slope (%)	N/A
	X Walk 1 X Slope (%)	3.1		X Walk 2 X Slope (%)	N/A

N/A	Ramp inside XWalk1?	N/A	N/A	Ramp inside XWalk2?	N/A
	Road Slope (%)	N/A	N/A	Clear Space?	N/A
	Road X Slope (%)	N/A	N/A	Clear Space to XWalk (in)	N/A
N/A	Any Obstructions?	N/A	N/A	Storm Grate/Utility Hazard?	N/A
	Obstruction Type			Storm Grate/Utility Type	
		N/A			N/A
			Yes	Surface Condition? (G/P)	Good

**Remove & Replace Entire Ramp.**
