Access Compliance Report

Public Rights-of-Way

(Curb Ramps)

Intersection ID: N/A	Main Street: ROCKY_RIVER_RD	Cross Street: JOHN_RUSSELL_RD	Location: SW
ADA ID: 0FD067CD0C08	Ramp Type: Perp	Initial Pass/Fail: Fail	Overall Compliance: No
Severity Score: 12.5			
Codes/Mitigation Info/Possible Solution		Field Measurements/Component Compliance

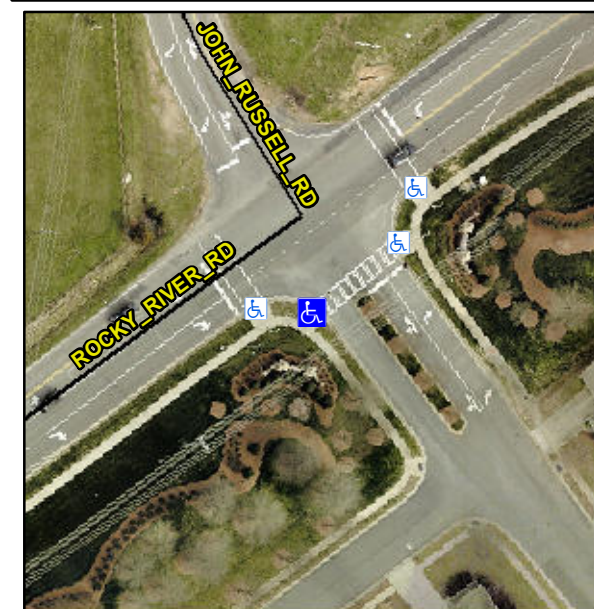
Compliance	Description	Data	Compliance	Description	Data
N/A	Ramp Length (in)	93.0	No	Ramp Slope (%)	10.4
Yes	Ramp Width (in)	48.0	Yes	Ramp XSlope (%)	0.5
N/A	Flare Type LT	N/A	N/A	Flare Type RT	N/A
N/A	Flare Slope LT (%)	N/A	N/A	Flare Slope RT (%)	N/A
N/A	Flare Traversable LT?	N/A	N/A	Flare Traversable RT?	N/A
N/A	Landing Length (in)	N/A	N/A	DWS Provided?	N/A
N/A	Landing Width (in)	N/A	N/A	DWS Contrast?	N/A
N/A	Landing Slope (%)	N/A	N/A	DWS Length (in)	N/A
N/A	Landing X Slope (%)	N/A	N/A	DWS Full Width?	N/A
N/A	Landing Curb? (Y/N)	N/A	N/A	DWS Offset (in)	N/A
N/A	Shared Landing?	N/A			
N/A	Gutter Ponding?	N/A	N/A	Gutter Slope (%)	N/A
N/A	Gutter Lip Ht (in)	N/A	N/A	Gutter X Slope (%)	N/A
N/A	Painted X Walk1?	Yes	N/A	Painted X Walk2?	N/A
	X Walk 1 Direction	To E		X Walk 2 Direction	N/A
N/A	X Walk 1 Width (in)	110.0	N/A	X Walk 2 Width (in)	N/A
	X Walk 1 Slope (%)	1.3		X Walk 2 Slope (%)	N/A
	X Walk 1 X Slope (%)	0.9		X Walk 2 X Slope (%)	N/A

N/A	Ramp inside XWalk1?	Yes	N/A	Ramp inside XWalk2?	N/A
	Road Slope (%)	N/A	N/A	Clear Space?	N/A
	Road X Slope (%)	N/A	N/A	Clear Space to XWalk (in)	N/A
N/A	Any Obstructions?	N/A	N/A	Storm Grate/Utility Hazard?	N/A
	Obstruction Type			Storm Grate/Utility Type	
		N/A			N/A
		Yes		Surface Condition? (G/P)	Good

Possible Solutions:

Remove & Replace Entire Ramp.

Not Found, R304.2.2
