Access Compliance Report Public Rights-of-Way (Curb Ramps)

Intersection ID: 13833 Main Street: WEST BV **Cross Street: N/A** Location: NW **ADA ID: 0FE03BA97B77** Ramp Type: Combination1Diag Initial Pass/Fail: Fail **Overall Compliance: No Severity Score:** 0

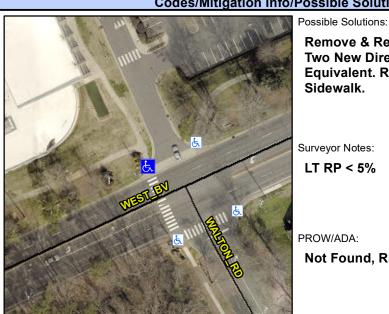
LT RP < 5%

Not Found, R304.5.3, R304.3.2

Comp	liance Description	Data	Comp	liance Description	Data
N/A	Ramp Length LT (in)	48.0	N/A	Ramp Length RT (in)	29.0
Yes	Ramp Width LT (in)	64.0	Yes	Ramp Width RT (in)	64.0
Yes	Ramp Slope LT (%)	2.2	No	Ramp Slope RT (%)	8.7
No	Ramp XSlope LT (%)	3.1	Yes	Ramp XSlope RT (%)	0.5
N/A	Ramp Length (in)	26.0	Yes	Ramp Slope (%)	7.9
Yes	Ramp Width (in)	48.0	Yes	Ramp XSlope (%)	1.5
N/A	Flare Type LT	N/A	N/A	Flare Type RT	N/A
N/A	Flare Slope LT (%)	N/A	N/A	Flare Slope RT (%)	N/A
N/A	Flare Traversable LT?	N/A	N/A	Flare Traversable RT?	N/A
N/A	Landing Length (in)	N/A	N/A	DWS Provided?	N/A
N/A	Landing Width (in)	N/A	N/A	DWS Contrast?	N/A
N/A	Landing Slope (%)	N/A	N/A	DWS Length (in)	N/A
N/A	Landing X Slope (%)	N/A	N/A	DWS Full Width?	N/A
N/A	Landing Curb? (Y/N)	N/A	N/A	DWS Offset (in)	N/A
N/A	Shared Landing?	N/A			
N/A	Gutter Ponding?	N/A	N/A	Gutter Slope (%)	N/A
N/A	Gutter Lip Ht (in)	N/A	N/A	Gutter X Slope (%)	N/A
N/A	Painted X Walk1?	Yes	N/A	Painted X Walk2?	No

Street 1 Name None **WEST BV** Stop Condition-Street 1 Street 2 Name StopSign Stop Condition-Street 2 N/A Remove & Replace Curb Ramp With Two New Directional Ramps or Equivalent. Remove & Replace Sidewalk.
