# Access Compliance Report

## Public Rights-of-Way

### (Curb Ramps)

Intersection ID: 9188	Main Street: BANCROFT_ST	Cross Street: NORRIS_AV	Location: S
ADA ID: 0FE7DC287BB3	Ramp Type: PerpDiag	Initial Pass/Fail: Fail	Overall Compliance: No
		Severity Score: 15

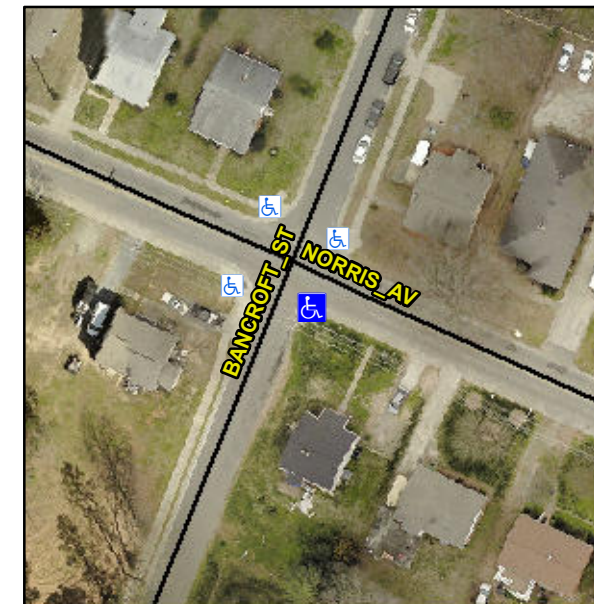
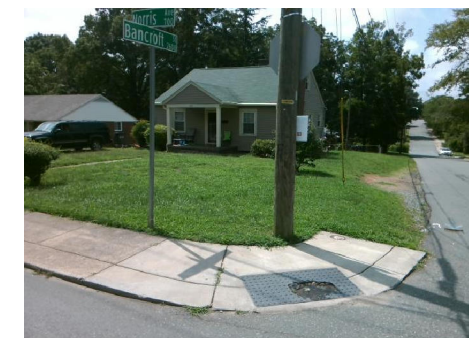
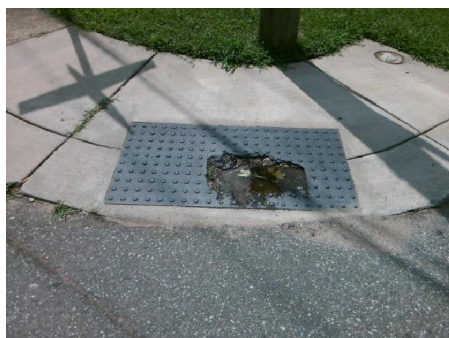
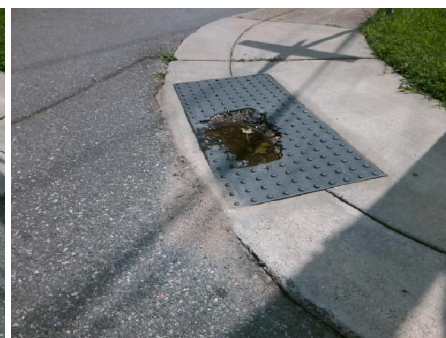
Compliance	Description	Data	Compliance	Description	Data
N/A	Ramp Length (in)	55.5	Yes	Ramp Slope (%)	6.4
Yes	Ramp Width (in)	50.0	Yes	Ramp XSlope (%)	2.0
N/A	Flare Type LT	N/A	N/A	Flare Type RT	N/A
N/A	Flare Slope LT (%)	N/A	N/A	Flare Slope RT (%)	N/A
N/A	Flare Traversable LT?	N/A	N/A	Flare Traversable RT?	N/A
N/A	Landing Length (in)	N/A	N/A	DWS Provided?	N/A
N/A	Landing Width (in)	N/A	N/A	DWS Contrast?	N/A
N/A	Landing Slope (%)	N/A	N/A	DWS Length (in)	N/A
N/A	Landing X Slope (%)	N/A	N/A	DWS Full Width?	N/A
N/A	Landing Curb? (Y/N)	N/A	N/A	DWS Offset (in)	N/A
N/A	Shared Landing?	N/A			
N/A	Gutter Ponding?	N/A	N/A	Gutter Slope (%)	N/A
N/A	Gutter Lip Ht (in)	0.5	N/A	Gutter X Slope (%)	N/A
N/A	Painted X Walk1?	No	N/A	Painted X Walk2?	No
	X Walk 1 Direction	To NE		X Walk 2 Direction	To NW
N/A	X Walk 1 Width (in)	N/A	N/A	X Walk 2 Width (in)	N/A
	X Walk 1 Slope (%)	6.9		X Walk 2 Slope (%)	1.1
	X Walk 1 X Slope (%)	0.5		X Walk 2 X Slope (%)	5.1

N/A	Ramp inside XWalk1?	N/A	N/A	Ramp inside XWalk2?	N/A
	Road Slope (%)	3.1	N/A	Clear Space?	N/A
	Road X Slope (%)	5.0	N/A	Clear Space to XWalk (in)	N/A
N/A	Any Obstructions?	N/A	N/A	Storm Grate/Utility Hazard?	N/A
	Obstruction Type			Storm Grate/Utility Type	
		N/A			N/A
		No		Surface Condition? (G/P)	Poor

**Remove & Replace Curb Ramp With Two New Directional Ramps or Equivalent.**

**R302.7**
