# Access Compliance Report

## Public Rights-of-Way

Intersection ID: 46308	Main Street: DONNEGAL_FARM_RD	Cross Street: BECKET RIDGE_RD	Location: SW
ADA ID: 0FEB8384A02A	Ramp Type: PerpDiag	Initial Pass/Fail: Fail	Overall Compliance: No
Severity Score: 8.75			
Codes/Mitigation Info/Possible Solution		Field Measurements/Component Compliance

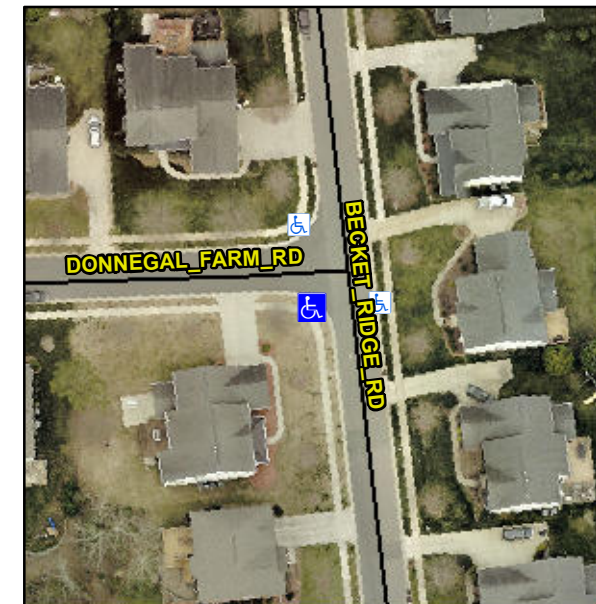
**Not Found, R304.5.1**

Compliance	Description	Data	Compliance	Description	Data
N/A	Ramp Length (in)	49.0	Yes	Ramp Slope (%)	5.2
No	Ramp Width (in)	47.5	Yes	Ramp XSlope (%)	0.8
N/A	Flare Type LT	N/A	N/A	Flare Type RT	N/A
N/A	Flare Slope LT (%)	N/A	N/A	Flare Slope RT (%)	N/A
N/A	Flare Traversable LT?	N/A	N/A	Flare Traversable RT?	N/A
N/A	Landing Length (in)	N/A	N/A	DWS Provided?	N/A
N/A	Landing Width (in)	N/A	N/A	DWS Contrast?	N/A
N/A	Landing Slope (%)	N/A	N/A	DWS Length (in)	N/A
N/A	Landing X Slope (%)	N/A	N/A	DWS Full Width?	N/A
N/A	Landing Curb? (Y/N)	N/A	N/A	DWS Offset (in)	N/A
N/A	Shared Landing?	N/A			
N/A	Gutter Ponding?	N/A	N/A	Gutter Slope (%)	N/A
N/A	Gutter Lip Ht (in)	N/A	N/A	Gutter X Slope (%)	N/A
N/A	Painted X Walk1?	No	N/A	Painted X Walk2?	No
	X Walk 1 Direction	To E		X Walk 2 Direction	To N
N/A	X Walk 1 Width (in)	N/A	N/A	X Walk 2 Width (in)	N/A
	X Walk 1 Slope (%)	1.6		X Walk 2 Slope (%)	4.4
	X Walk 1 X Slope (%)	4.8		X Walk 2 X Slope (%)	3.6

N/A	Ramp inside XWalk1?	N/A	N/A	Ramp inside XWalk2?	N/A
	Road Slope (%)	0.5	N/A	Clear Space?	N/A
	Road X Slope (%)	5.9	N/A	Clear Space to XWalk (in)	N/A
N/A	Any Obstructions?	N/A	N/A	Storm Grate/Utility Hazard?	N/A
	Obstruction Type			Storm Grate/Utility Type	
		N/A			N/A
			Yes	Surface Condition? (G/P)	Good

**Remove & Replace Curb Ramp With Two New Directional Ramps or Equivalent.**
