## **Access Compliance Report Public Rights-of-Way** (Curb Ramps)

Intersection ID: 20860 Main Street: CROWNPOINT EXECUTIVE DRCross Street: KREFELD DR Location: NW ADA ID: 100680BC57B0 Ramp Type: PerpDiag Initial Pass/Fail: Fail **Overall Compliance: No Severity Score:** 22.5

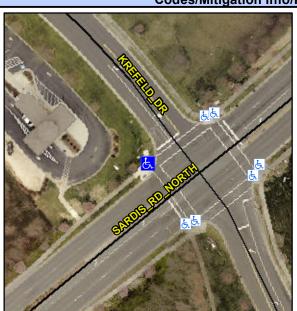
Field Measurements/Component Compilance									
Compliance Description		Data	Comp	oliance Description	Data				
N/A	Ramp Length (in)	69.0	No	Ramp Slope (%)	8.8				
No	Ramp Width (in)	47.5	No	Ramp XSlope (%)	3.7				
N/A	Flare Type LT	N/A	N/A	Flare Type RT	N/A				
N/A	Flare Slope LT (%)	N/A	N/A	Flare Slope RT (%)	N/A				
N/A	Flare Traversable LT?	N/A	N/A	Flare Traversable RT?	N/A				
N/A	Landing Length (in)	N/A	N/A	DWS Provided?	N/A				
N/A	Landing Width (in)	N/A	N/A	DWS Contrast?	N/A				
N/A	Landing Slope (%)	N/A	N/A	DWS Length (in)	N/A				
N/A	Landing X Slope (%)	N/A	N/A	DWS Full Width?	N/A				
N/A	Landing Curb? (Y/N)	N/A	N/A	DWS Offset (in)	N/A				
N/A	Shared Landing?	N/A							
N/A	Gutter Ponding?	N/A	N/A	Gutter Slope (%)	N/A				
N/A	Gutter Lip Ht (in)	N/A	N/A	Gutter X Slope (%)	N/A				
N/A	Painted X Walk1?	Yes	N/A	Painted X Walk2?	Yes				
	X Walk 1 Direction	To SE		X Walk 2 Direction	To NE				
N/A	X Walk 1 Width (in)	117.0	N/A	X Walk 2 Width (in)	108.0

X Walk 1 Slope (%)	4.1		X Walk 2 Slope (%)	2.5				
	X Walk 1 X Slope (%)	3.9		X Walk 2 X Slope (%)	4.1				
N/A	Ramp inside XWalk1?	Yes	N/A	Ramp inside XWalk2?	Yes				
	Road Slope (%)	2.7	N/A	Clear Space?	N/A				
	Road X Slope (%)	6.0	N/A	Clear Space to XWalk (in)	N/A				
N/A	Any Obstructions?	N/A	N/A	Storm Grate/Utility Hazard?	N/A				
	Obstruction Type			Storm Grate/Utility Type					
		N/A			N/A				
			Yes	Surface Condition? (G/P)	Good				
	W1 15 0 0 0 0 0 0 0 0 0 0 0 0 0 0 0 0 0 0

**CROWNPOINT EXECUTIVE DR** Street 1 Name Stop Condition-Street 2 Signal Street 2 Name **KREFELD DR** Stop Condition-Street 1 Signal Possible Solutions: Remove & Replace Curb Ramp With Two New Directional Ramps or Equivalent. Surveyor Notes:

·// (D/ (.					
Found, 04.5.3	R304.5.1	, R304	.2.2,		
Cost:			\$	3200.00
