Intersection ID: 14809	Main Street: OLD_MEADOW_RD	Cross Street: WINTER_ELM_LN	Location:	SW
ADA ID: 101246B7B530	Ramp Type: PerpDiag	Initial Pass/Fail: Fail	Overall Compliance: No	Severity Score: 12.5

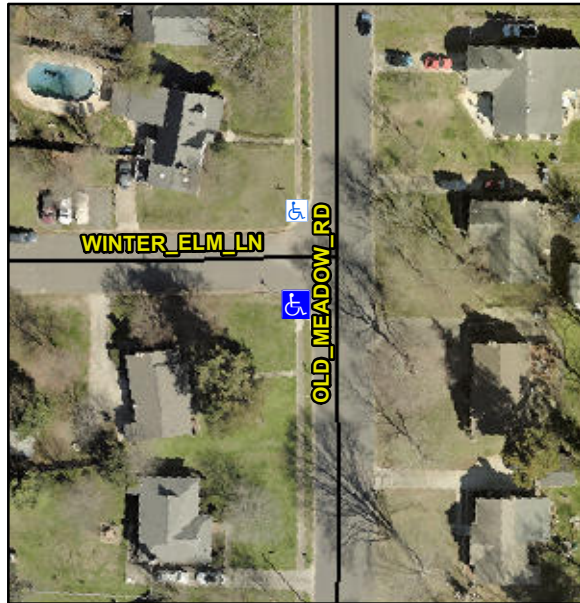
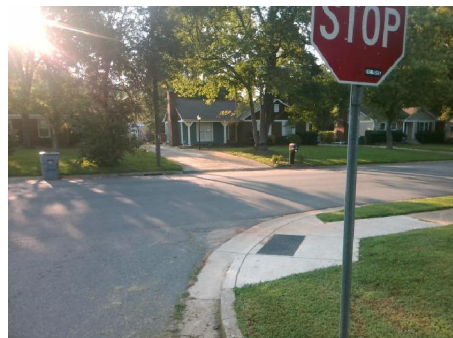
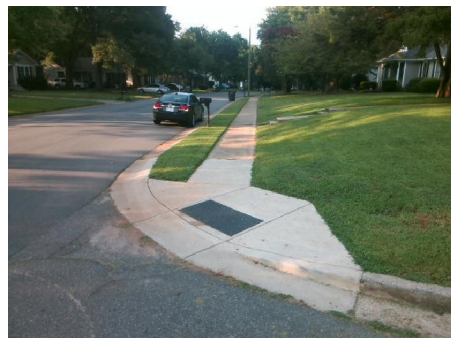
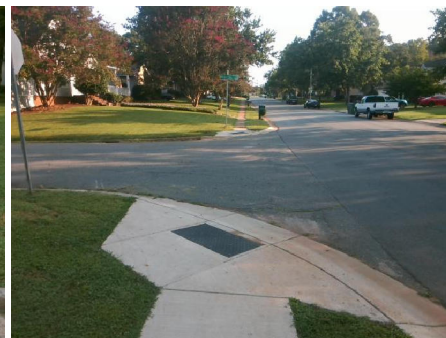
Compliance	Description	Data	Compliance	Description	Data
N/A	Ramp Length (in)	67.0	Yes	Ramp Slope (%)	5.5
Yes	Ramp Width (in)	52.0	No	Ramp XSlope (%)	5.4
N/A	Flare Type LT	N/A	N/A	Flare Type RT	N/A
N/A	Flare Slope LT (%)	N/A	N/A	Flare Slope RT (%)	N/A
N/A	Flare Traversable LT?	N/A	N/A	Flare Traversable RT?	N/A
N/A	Landing Length (in)	N/A	N/A	DWS Provided?	N/A
N/A	Landing Width (in)	N/A	N/A	DWS Contrast?	N/A
N/A	Landing Slope (%)	N/A	N/A	DWS Length (in)	N/A
N/A	Landing X Slope (%)	N/A	N/A	DWS Full Width?	N/A
N/A	Landing Curb? (Y/N)	N/A	N/A	DWS Offset (in)	N/A
N/A	Shared Landing?	N/A			
N/A	Gutter Ponding?	N/A	N/A	Gutter Slope (%)	N/A
N/A	Gutter Lip Ht (in)	1.0	N/A	Gutter X Slope (%)	N/A
N/A	Painted X Walk1?	No	N/A	Painted X Walk2?	No
	X Walk 1 Direction	To SE		X Walk 2 Direction	To NE
N/A	X Walk 1 Width (in)	N/A	N/A	X Walk 2 Width (in)	N/A
	X Walk 1 Slope (%)	3.2		X Walk 2 Slope (%)	4.9
	X Walk 1 X Slope (%)	3.0		X Walk 2 X Slope (%)	0.3

N/A	Ramp inside XWalk1?	N/A	N/A	Ramp inside XWalk2?	N/A
	Road Slope (%)	3.5	N/A	Clear Space?	N/A
	Road X Slope (%)	4.5	N/A	Clear Space to XWalk (in)	N/A
N/A	Any Obstructions?	N/A	N/A	Storm Grate/Utility Hazard?	N/A
	Obstruction Type			Storm Grate/Utility Type	
		N/A			N/A
			Yes	Surface Condition? (G/P)	Good

Remove & Replace Curb Ramp With Two New Directional Ramps or Equivalent.

R304.5.3

\$ 3200.00
