# Access Compliance Report

## Public Rights-of-Way

### (Curb Ramps)

Intersection ID: 28521	Main Street: LIONSTONE_DR	Cross Street: GARRISON_RD	Location: W
ADA ID: 102A381573A8	Ramp Type: Perp	Initial Pass/Fail: Fail	Overall Compliance: No
Codes/Mitigation Info/Possible Solution		Field Measurements/Component Compliance	
Severity Score: 33.75

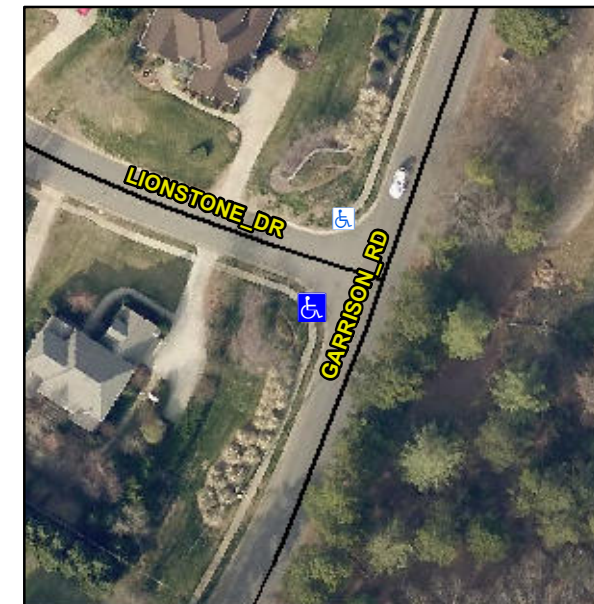
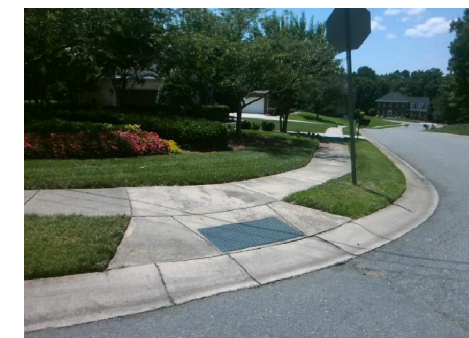
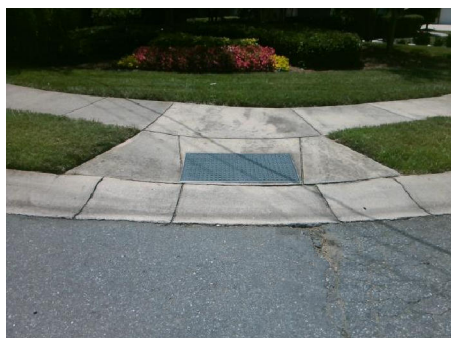
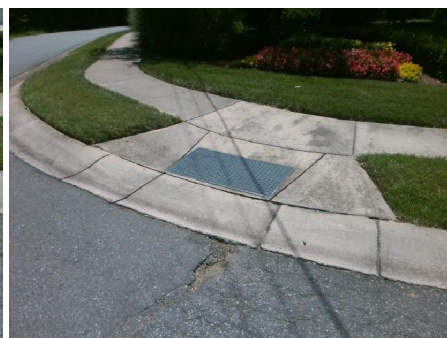
**Not Found, R304.5.1, R304.5.3**

Compliance	Description	Data	Compliance	Description	Data
N/A	Ramp Length (in)	44.0	Yes	Ramp Slope (%)	5.5
No	Ramp Width (in)	45.0	No	Ramp XSlope (%)	7.0
N/A	Flare Type LT	N/A	N/A	Flare Type RT	N/A
N/A	Flare Slope LT (%)	N/A	N/A	Flare Slope RT (%)	N/A
N/A	Flare Traversable LT?	N/A	N/A	Flare Traversable RT?	N/A
N/A	Landing Length (in)	N/A	N/A	DWS Provided?	N/A
N/A	Landing Width (in)	N/A	N/A	DWS Contrast?	N/A
N/A	Landing Slope (%)	N/A	N/A	DWS Length (in)	N/A
N/A	Landing X Slope (%)	N/A	N/A	DWS Full Width?	N/A
N/A	Landing Curb? (Y/N)	N/A	N/A	DWS Offset (in)	N/A
N/A	Shared Landing?	N/A			
N/A	Gutter Ponding?	N/A	N/A	Gutter Slope (%)	N/A
N/A	Gutter Lip Ht (in)	N/A	N/A	Gutter X Slope (%)	N/A
N/A	Painted X Walk1?	No	N/A	Painted X Walk2?	N/A
	X Walk 1 Direction	To NE		X Walk 2 Direction	N/A
N/A	X Walk 1 Width (in)	N/A	N/A	X Walk 2 Width (in)	N/A
	X Walk 1 Slope (%)	0.5		X Walk 2 Slope (%)	N/A
	X Walk 1 X Slope (%)	8.2		X Walk 2 X Slope (%)	N/A

N/A	Ramp inside XWalk1?	N/A	N/A	Ramp inside XWalk2?	N/A
	Road Slope (%)	N/A	N/A	Clear Space?	N/A
	Road X Slope (%)	N/A	N/A	Clear Space to XWalk (in)	N/A
N/A	Any Obstructions?	N/A	N/A	Storm Grate/Utility Hazard?	N/A
	Obstruction Type			Storm Grate/Utility Type	
		N/A			N/A
			Yes	Surface Condition? (G/P)	Good

**Remove & Replace Entire Ramp.**

Total Cost: \$ 1850.00
