Intersection ID: 23706	Main Street: CARPET_ST	Cross Street: WESTINGHOUSE_BV	Location:	NE
ADA ID: 1033AC0FA1A0	Ramp Type: PerpDiag	Initial Pass/Fail: Fail	Overall Compliance: No	Severity Score: 36.25

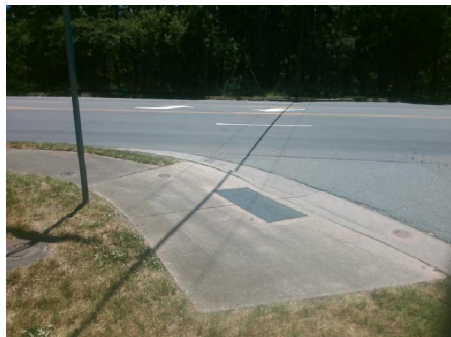
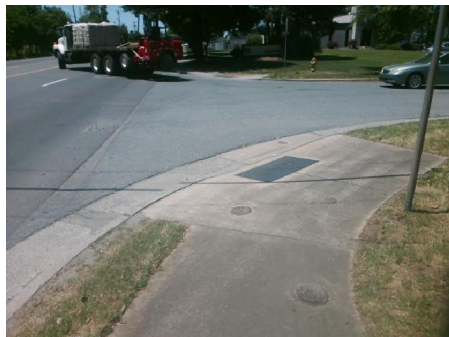
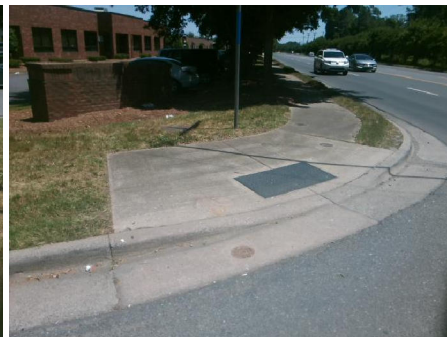
**Not Found, R304.5.1, R304.5.3**

Compliance	Description	Data	Compliance	Description	Data
N/A	Ramp Length (in)	84.0	Yes	Ramp Slope (%)	6.6
No	Ramp Width (in)	24.0	No	Ramp XSlope (%)	3.4
N/A	Flare Type LT	N/A	N/A	Flare Type RT	N/A
N/A	Flare Slope LT (%)	N/A	N/A	Flare Slope RT (%)	N/A
N/A	Flare Traversable LT?	N/A	N/A	Flare Traversable RT?	N/A
N/A	Landing Length (in)	N/A	N/A	DWS Provided?	N/A
N/A	Landing Width (in)	N/A	N/A	DWS Contrast?	N/A
N/A	Landing Slope (%)	N/A	N/A	DWS Length (in)	N/A
N/A	Landing X Slope (%)	N/A	N/A	DWS Full Width?	N/A
N/A	Landing Curb? (Y/N)	N/A	N/A	DWS Offset (in)	N/A
N/A	Shared Landing?	N/A			
N/A	Gutter Ponding?	N/A	N/A	Gutter Slope (%)	N/A
N/A	Gutter Lip Ht (in)	N/A	N/A	Gutter X Slope (%)	N/A
N/A	Painted X Walk1?	No	N/A	Painted X Walk2?	No
	X Walk 1 Direction	To W		X Walk 2 Direction	To S
N/A	X Walk 1 Width (in)	N/A	N/A	X Walk 2 Width (in)	N/A
	X Walk 1 Slope (%)	1.6		X Walk 2 Slope (%)	0.2
	X Walk 1 X Slope (%)	2.8		X Walk 2 X Slope (%)	0.6

N/A	Ramp inside XWalk1?	N/A	N/A	Ramp inside XWalk2?	N/A
	Road Slope (%)	2.4	N/A	Clear Space?	N/A
	Road X Slope (%)	2.8	N/A	Clear Space to XWalk (in)	N/A
N/A	Any Obstructions?	N/A	N/A	Storm Grate/Utility Hazard?	N/A
	Obstruction Type			Storm Grate/Utility Type	
		N/A			N/A
			Yes	Surface Condition? (G/P)	Good

**Remove & Replace Curb Ramp With Two New Directional Ramps or Equivalent.**
