## Access Compliance Report Public Rights-of-Way (Curb Ramps)

Intersection ID: 9212	2 Main Street: CLYDE_DR			Cross	Street:	CORONET_WY	Location:	S			
ADA ID: 103EE5A2622A	3EE5A2622A Ramp Type: Perp			Initial	Initial Pass/Fail: Fail Overall Compliance: No				o Severity Score:	72.5	
Codes/Mitigation Info/Possible Solution					Field Measurements/Component Compliance						
		Possible Solutions:			Compliance Description			Data Compliance Description		Data	
		Remove & Replace Ent	ire Ram	р.	N/A	Ramp Length (in)	71.0	No	Ramp Slope (%)	11.1

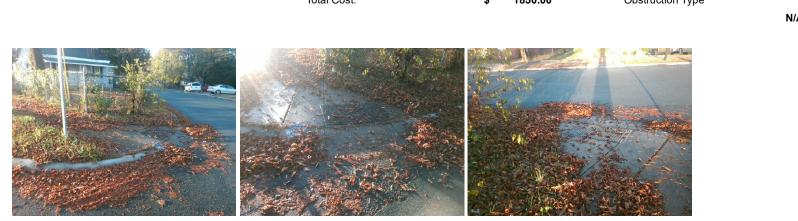
•		•	No	Ramp Width (in)	31.5	No	Ramp XSlope (%)	7.3	
					N/A	Flare Type LT	N/A	N/A	Flare Type RT	N/A	
					N/A	Flare Slope LT (%)	N/A	N/A	Flare Slope RT (%)	N/A	
All and	and the second s				N/A	Flare Traversable LT?	N/A	N/A	Flare Traversable RT?	N/A	
	A CONTRACTOR				N/A	Landing Length (in)	N/A	N/A	DWS Provided?	N/A	
Contraction of the second		Surveyor Notes:			N/A	Landing Width (in)	N/A	N/A	DWS Contrast?	N/A	
		N/A			N/A	Landing Slope (%)	N/A	N/A	DWS Length (in)	N/A	
					N/A	Landing X Slope (%)	N/A	N/A	DWS Full Width?	N/A	
	1 Alexandre				N/A	Landing Curb? (Y/N)	N/A	N/A	DWS Offset (in)	N/A	
	the				N/A	Shared Landing?	N/A				
And And And And	1 Es	PROW/ADA:			N/A	Gutter Ponding?	N/A	N/A	Gutter Slope (%)	N/A	
Carlos H Carlos	31113	Not Found, R304.5.1, R	304.2.2	,	N/A	Gutter Lip Ht (in)	N/A	N/A	Gutter X Slope (%)	N/A	
		R304.5.3		-	N/A	Painted X Walk1?	No	N/A	Painted X Walk2?	N/A	
The state of the second						X Walk 1 Direction	To NW		X Walk 2 Direction	N/A
