# Access Compliance Report

## Public Rights-of-Way

### (Curb Ramps)

Intersection ID: 4937	Main Street: CASTLEMAINE_DR	Cross Street: GRANARD_LN	Location: NE
ADA ID: 10471FB819A6	Ramp Type: Perp	Initial Pass/Fail: Fail	Overall Compliance: No
Codes/Mitigation Info/Possible Solution			Severity Score: 25
			Field Measurements/Component Compliance

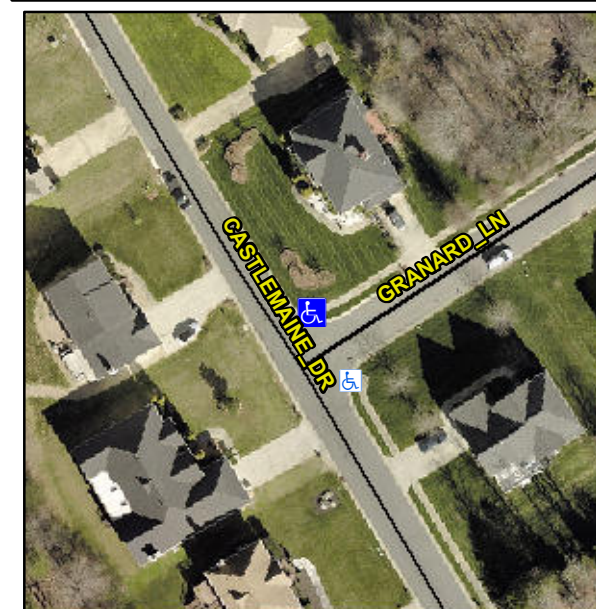
Compliance	Description	Data	Compliance	Description	Data
N/A	Ramp Length (in)	47.0	No	Ramp Slope (%)	11.2
Yes	Ramp Width (in)	59.0	No	Ramp XSlope (%)	5.1
N/A	Flare Type LT	N/A	N/A	Flare Type RT	N/A
N/A	Flare Slope LT (%)	N/A	N/A	Flare Slope RT (%)	N/A
N/A	Flare Traversable LT?	N/A	N/A	Flare Traversable RT?	N/A
N/A	Landing Length (in)	N/A	N/A	DWS Provided?	N/A
N/A	Landing Width (in)	N/A	N/A	DWS Contrast?	N/A
N/A	Landing Slope (%)	N/A	N/A	DWS Length (in)	N/A
N/A	Landing X Slope (%)	N/A	N/A	DWS Full Width?	N/A
N/A	Landing Curb? (Y/N)	N/A	N/A	DWS Offset (in)	N/A
N/A	Shared Landing?	N/A			
N/A	Gutter Ponding?	N/A	N/A	Gutter Slope (%)	N/A
N/A	Gutter Lip Ht (in)	N/A	N/A	Gutter X Slope (%)	N/A
N/A	Painted X Walk1?	No	N/A	Painted X Walk2?	N/A
	X Walk 1 Direction	To S		X Walk 2 Direction	N/A
N/A	X Walk 1 Width (in)	N/A	N/A	X Walk 2 Width (in)	N/A
	X Walk 1 Slope (%)	1.3		X Walk 2 Slope (%)	N/A
	X Walk 1 X Slope (%)	10.7		X Walk 2 X Slope (%)	N/A

N/A	Ramp inside XWalk1?	N/A	N/A	Ramp inside XWalk2?	N/A
	Road Slope (%)	N/A	N/A	Clear Space?	N/A
	Road X Slope (%)	N/A	N/A	Clear Space to XWalk (in)	N/A
N/A	Any Obstructions?	N/A	N/A	Storm Grate/Utility Hazard?	N/A
	Obstruction Type			Storm Grate/Utility Type	
		N/A			N/A
			Yes	Surface Condition? (G/P)	Good

**Remove & Replace Entire Ramp.**

**R304.2.2, R304.5.3**

Total Cost: \$ 1850.00
