Access Compliance Report

Public Rights-of-Way

(Curb Ramps)

Intersection ID: N/A	Main Street: PHILLIPS_AV	Cross Street: MAYFLOWER_RD	Location: SW
ADA ID: 105D55260669	Ramp Type: Directional1	Initial Pass/Fail: Fail	Overall Compliance: No
Codes/Mitigation Info/Possible Solution		Field Measurements/Component Compliance	
Severity Score: 13.75

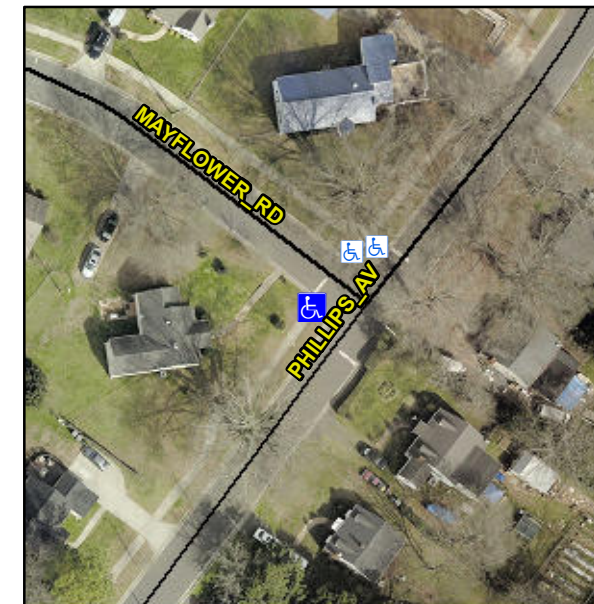
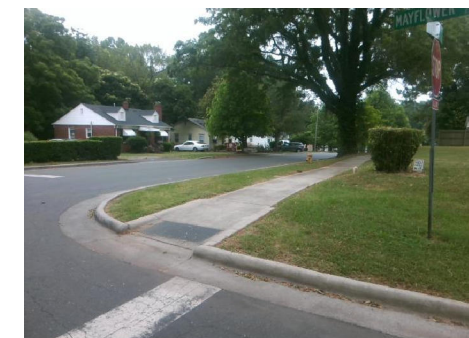
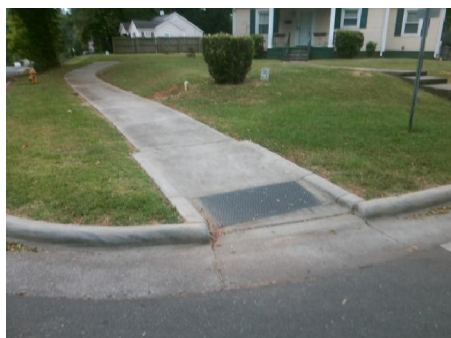
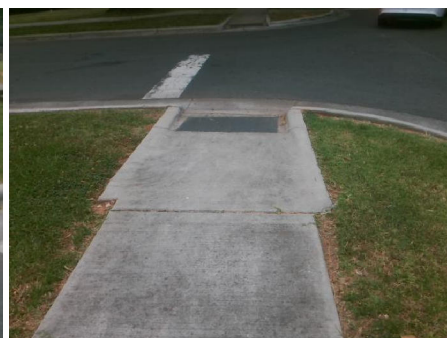
R304.2.2, R304.5.3

Compliance	Description	Data	Compliance	Description	Data
N/A	Ramp Length (in)	97.0	N/A	Grade Break?	N/A
Yes	Ramp Width (in)	54.0	N/A	Grade Break Slope (%)	0.0
No	Ramp Slope (%)	8.5	N/A	Grade Break XSlope (%)	0.0
No	Ramp XSlope (%)	2.4			
N/A	Flare Type LT	N/A	N/A	Flare Type RT	N/A
N/A	Flare Slope LT (%)	N/A	N/A	Flare Slope RT (%)	0.0
N/A	Flare Traversable LT?	N/A	N/A	Flare Traversable RT?	N/A
N/A	Landing Length (in)	0.0	N/A	DWS Provided?	N/A
N/A	Landing Width (in)	0.0	N/A	DWS Contrast?	N/A
N/A	Landing Slope (%)	0.0	N/A	DWS Length (in)	N/A
N/A	Landing X Slope (%)	0.0	N/A	DWS Full Width?	N/A
N/A	Landing Curb? (Y/N)	N/A	N/A	DWS Offset LT (in)	N/A
N/A	Shared Landing?	N/A	N/A	DWS Offset RT (in)	N/A
N/A	Gutter Ponding?	0.0	N/A	Gutter Slope (%)	N/A
N/A	Gutter Lip Ht (in)	0.0	N/A	Gutter X Slope (%)	N/A
N/A	Painted X Walk1?	No		Road Slope (%)	1.5
	X Walk 1 Direction	To N		Road X Slope (%)	1.5
	X Walk 1 Width (in)	N/A		Clear Space?	N/A

X Walk 1 Slope (%)	1.5	N/A	Clear Space to XWalk (in)	N/A
	X Walk 1 X Slope (%)	1.5	N/A	Storm Grate/Utility Hazard?	N/A
N/A	Ramp inside XWalk1?	N/A		Storm Grate/Utility Type	
N/A	Any Obstructions?	N/A			N/A
	Obstruction Type		Yes	Surface Condition? (G/P)	Good
			N/A	Curb Slope (%)	11.0

Remove & Replace Entire Ramp.
