# Access Compliance Report

## Public Rights-of-Way

### (Curb Ramps)

Intersection ID: 3762	Main Street: MERION_HILLS_CT	Cross Street: TRADITION_VIEW_DR	Location: SE
ADA ID: 106C7240F8B1	Ramp Type: Perp	Initial Pass/Fail: Fail	Overall Compliance: No
Codes/Mitigation Info/Possible Solution		Field Measurements/Component Compliance	
Severity Score: 46.25

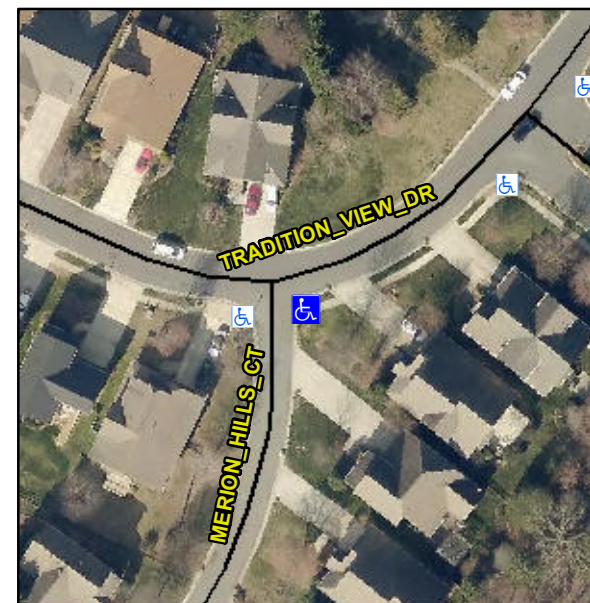
**Not Found, R304.5.1, R304.2.2, R304.5.3**

Compliance	Description	Data	Compliance	Description	Data
N/A	Ramp Length (in)	96.0	No	Ramp Slope (%)	9.2
No	Ramp Width (in)	46.0	No	Ramp XSlope (%)	9.9
N/A	Flare Type LT	N/A	N/A	Flare Type RT	N/A
N/A	Flare Slope LT (%)	N/A	N/A	Flare Slope RT (%)	N/A
N/A	Flare Traversable LT?	N/A	N/A	Flare Traversable RT?	N/A
N/A	Landing Length (in)	N/A	N/A	DWS Provided?	N/A
N/A	Landing Width (in)	N/A	N/A	DWS Contrast?	N/A
N/A	Landing Slope (%)	N/A	N/A	DWS Length (in)	N/A
N/A	Landing X Slope (%)	N/A	N/A	DWS Full Width?	N/A
N/A	Landing Curb? (Y/N)	N/A	N/A	DWS Offset (in)	N/A
N/A	Shared Landing?	N/A			
N/A	Gutter Ponding?	N/A	N/A	Gutter Slope (%)	N/A
N/A	Gutter Lip Ht (in)	N/A	N/A	Gutter X Slope (%)	N/A
N/A	Painted X Walk1?	No	N/A	Painted X Walk2?	N/A
	X Walk 1 Direction	To W		X Walk 2 Direction	N/A
N/A	X Walk 1 Width (in)	N/A	N/A	X Walk 2 Width (in)	N/A
	X Walk 1 Slope (%)	1.7		X Walk 2 Slope (%)	N/A
	X Walk 1 X Slope (%)	7.0		X Walk 2 X Slope (%)	N/A

N/A	Ramp inside XWalk1?	N/A	N/A	Ramp inside XWalk2?	N/A
	Road Slope (%)	N/A	N/A	Clear Space?	N/A
	Road X Slope (%)	N/A	N/A	Clear Space to XWalk (in)	N/A
N/A	Any Obstructions?	N/A	N/A	Storm Grate/Utility Hazard?	N/A
	Obstruction Type			Storm Grate/Utility Type	
		N/A			N/A
			Yes	Surface Condition? (G/P)	Good

**Remove & Replace Entire Ramp.**
