## Access Compliance Report Public Rights-of-Way (Curb Ramps)

Intersection ID: 50302 Main Street: PINE\_CHAPEL\_DR Cross Street: PINE\_TERRACE\_CT Location: NE
ADA ID: 106D9ED07B75 Ramp Type: PerpDiag Initial Pass/Fail: Fail Overall Compliance: No Severity Score: 8.75

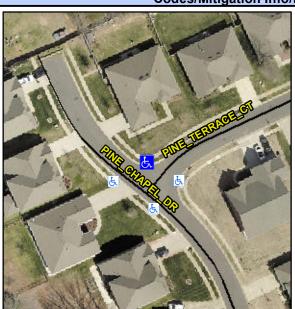
Compliance Description		Data	Compliance Description		Data	
N/A	Ramp Length (in)	49.5	Yes	Ramp Slope (%)	7.0	
No	Ramp Width (in)	47.0	Yes	Ramp XSlope (%)	1.7	
N/A	Flare Type LT	N/A	N/A	Flare Type RT	N/A	
N/A	Flare Slope LT (%)	N/A	N/A	Flare Slope RT (%)	N/A	
N/A	Flare Traversable LT?	N/A	N/A	Flare Traversable RT?	N/A	
N/A	Landing Length (in)	N/A	N/A	DWS Provided?	N/A	
N/A	Landing Width (in)	N/A	N/A	DWS Contrast?	N/A	
N/A	Landing Slope (%)	N/A	N/A	DWS Length (in)	N/A	
N/A	Landing X Slope (%)	N/A	N/A	DWS Full Width?	N/A	
N/A	Landing Curb? (Y/N)	N/A	N/A	DWS Offset (in)	N/A	
N/A	Shared Landing?	N/A				
N/A	Gutter Ponding?	N/A	N/A	Gutter Slope (%)	N/A	
N/A	Gutter Lip Ht (in)	N/A	N/A	Gutter X Slope (%)	N/A	
N/A	Painted X Walk1?	No	N/A	Painted X Walk2?	No	
	X Walk 1 Direction	To SW		X Walk 2 Direction	To SE	
N/A	X Walk 1 Width (in)	N/A	N/A	X Walk 2 Width (in)	N/A	
	X Walk 1 Slope (%)	4.1		X Walk 2 Slope (%)	1.5	
	X Walk 1 X Slope (%)	2.1		X Walk 2 X Slope (%)	1.5

N/A	Ramp inside XWalk1?	N/A	N/A	Ramp inside XWalk2?	N/A	
	Road Slope (%)	2.6	N/A	Clear Space?	N/A	
	Road X Slope (%)	0.2	N/A	Clear Space to XWalk (in)	N/A	
N/A	Any Obstructions?	N/A	N/A	Storm Grate/Utility Hazard?	N/A	
	Obstruction Type		l	Storm Grate/Utility Type		
		N/A			N/A	
			Yes	Surface Condition? (G/P)	Good

PINE CHAPEL DR None PINE TERRACE CT StopSign Possible Solutions:

Remove & Replace Curb Ramp With Two New Directional Ramps or Equivalent.

R304.5.1
