Access Compliance Report

Public Rights-of-Way

(Curb Ramps)

Intersection ID: 4398	Main Street: AMARANTHUS_CT	Cross Street: BROOKSTONE_DR	Location: NW
ADA ID: 107A762D6806	Ramp Type: PerpDiag	Initial Pass/Fail: Fail	Overall Compliance: No
		Severity Score: 35

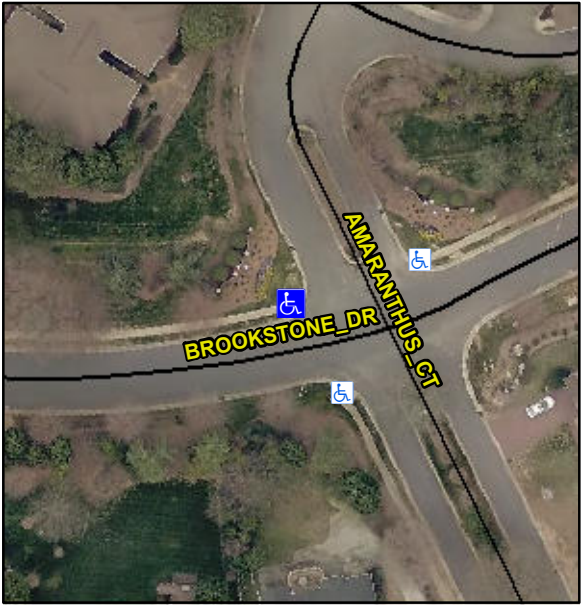
Possible Solutions:		Compliance	Description	Data
	Remove & Replace Curb Ramp With Two New Directional Ramps or Equivalent.		No	Ramp Length (in)	99.0
			No	Ramp Width (in)	46.0
			N/A	Flare Type LT	N/A
			N/A	Flare Slope LT (%)	N/A
			N/A	Flare Traversable LT?	N/A
			N/A	Landing Length (in)	N/A
			N/A	Landing Width (in)	N/A
			N/A	Landing Slope (%)	N/A
			N/A	Landing X Slope (%)	N/A
<p>Surveyor Notes:</p> <p>N/A</p> <p>PROW/ADA:</p> <p>Not Found, R304.5.1, R304.2.2, R304.5.3</p>			N/A	Flare Type RT	N/A
			N/A	Flare Slope RT (%)	N/A
			N/A	Flare Traversable RT?	N/A
			N/A	DWS Provided?	N/A
			N/A	DWS Contrast?	N/A
			N/A	DWS Length (in)	N/A
			N/A	DWS Full Width?	N/A
			N/A	DWS Offset (in)	N/A
			N/A	Gutter Ponding?	N/A
			N/A	Gutter Lip Ht (in)	N/A
<p>Total Cost:</p> <p>\$ 3200.00</p>			No	Painted X Walk1?	No
			To S	X Walk 2 Direction	To E

N/A	X Walk 2 Width (in)	N/A
			5.6	X Walk 2 Slope (%)	3.0
			1.4	X Walk 2 X Slope (%)	3.3
			N/A	Ramp inside XWalk2?	N/A
			5.0	Clear Space?	N/A
			2.4	Clear Space to XWalk (in)	N/A
			N/A	Storm Grate/Utility Hazard?	N/A
			N/A	Storm Grate/Utility Type	N/A
			N/A	Surface Condition? (G/P)	Good
