# Access Compliance Report

## Public Rights-of-Way

### (Curb Ramps)

Intersection ID: 44823	Main Street: SPRING_OAK_DR	Cross Street: GOLDEN_RIDGE_LN	Location: SW
ADA ID: 1084A412CE73	Ramp Type: PerpDiag	Initial Pass/Fail: Fail	Overall Compliance: No
Severity Score: 42.5			
Codes/Mitigation Info/Possible Solution		Field Measurements/Component Compliance

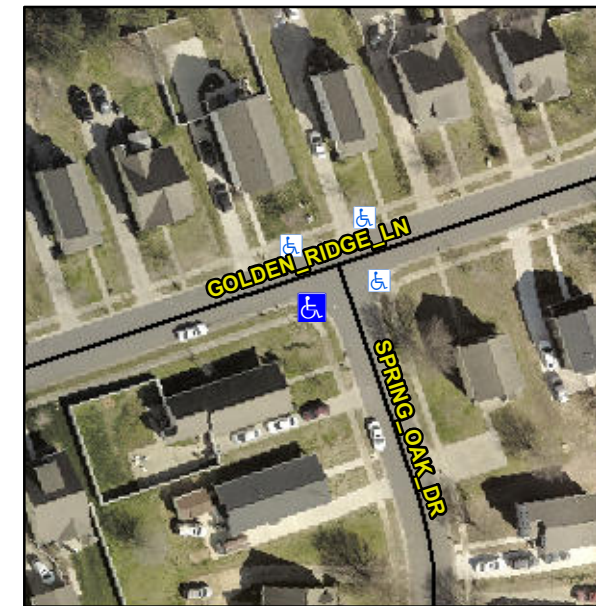
Compliance	Description	Data	Compliance	Description	Data
N/A	Ramp Length (in)	96.0	Yes	Ramp Slope (%)	7.2
No	Ramp Width (in)	35.0	No	Ramp XSlope (%)	13.1
N/A	Flare Type LT	N/A	N/A	Flare Type RT	N/A
N/A	Flare Slope LT (%)	N/A	N/A	Flare Slope RT (%)	N/A
N/A	Flare Traversable LT?	N/A	N/A	Flare Traversable RT?	N/A
N/A	Landing Length (in)	N/A	N/A	DWS Provided?	N/A
N/A	Landing Width (in)	N/A	N/A	DWS Contrast?	N/A
N/A	Landing Slope (%)	N/A	N/A	DWS Length (in)	N/A
N/A	Landing X Slope (%)	N/A	N/A	DWS Full Width?	N/A
N/A	Landing Curb? (Y/N)	N/A	N/A	DWS Offset (in)	N/A
N/A	Shared Landing?	N/A			
N/A	Gutter Ponding?	N/A	N/A	Gutter Slope (%)	N/A
N/A	Gutter Lip Ht (in)	N/A	N/A	Gutter X Slope (%)	N/A
N/A	Painted X Walk1?	No	N/A	Painted X Walk2?	No
	X Walk 1 Direction	To E		X Walk 2 Direction	To N
N/A	X Walk 1 Width (in)	N/A	N/A	X Walk 2 Width (in)	N/A
	X Walk 1 Slope (%)	3.3		X Walk 2 Slope (%)	4.5
	X Walk 1 X Slope (%)	4.7		X Walk 2 X Slope (%)	5.7

N/A	Ramp inside XWalk1?	N/A	N/A	Ramp inside XWalk2?	N/A
	Road Slope (%)	7.1	N/A	Clear Space?	N/A
	Road X Slope (%)	3.5	N/A	Clear Space to XWalk (in)	N/A
N/A	Any Obstructions?	N/A	N/A	Storm Grate/Utility Hazard?	N/A
	Obstruction Type			Storm Grate/Utility Type	
		N/A			N/A
		Yes		Surface Condition? (G/P)	Good

Possible Solutions:

**Remove & Replace Curb Ramp With Two New Directional Ramps or Equivalent.**

**R304.5.1, R304.5.3**
