Access Compliance Report

Public Rights-of-Way

(Curb Ramps)

Intersection ID: 4075	Main Street: OVERLOOK_MOUNTAIN_DR	Cross Street: MOUNTAIN_COVE_DR	Location:	N
ADA ID: 1088E8B07F10	Ramp Type: Perp	Initial Pass/Fail: Fail	Overall Compliance: No	Severity Score: 1.25
Codes/Mitigation Info/Possible Solution		Field Measurements/Component Compliance

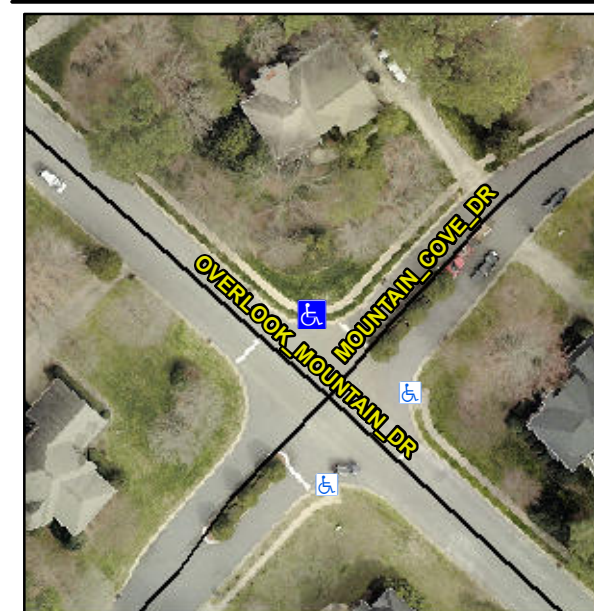
Not Found, R304.5.3

Compliance	Description	Data	Compliance	Description	Data
N/A	Ramp Length (in)	97.0	Yes	Ramp Slope (%)	5.8
Yes	Ramp Width (in)	49.0	No	Ramp XSlope (%)	4.1
N/A	Flare Type LT	N/A	N/A	Flare Type RT	N/A
N/A	Flare Slope LT (%)	N/A	N/A	Flare Slope RT (%)	N/A
N/A	Flare Traversable LT?	N/A	N/A	Flare Traversable RT?	N/A
N/A	Landing Length (in)	N/A	N/A	DWS Provided?	N/A
N/A	Landing Width (in)	N/A	N/A	DWS Contrast?	N/A
N/A	Landing Slope (%)	N/A	N/A	DWS Length (in)	N/A
N/A	Landing X Slope (%)	N/A	N/A	DWS Full Width?	N/A
N/A	Landing Curb? (Y/N)	N/A	N/A	DWS Offset (in)	N/A
N/A	Shared Landing?	N/A			
N/A	Gutter Ponding?	N/A	N/A	Gutter Slope (%)	N/A
N/A	Gutter Lip Ht (in)	N/A	N/A	Gutter X Slope (%)	N/A
N/A	Painted X Walk1?	No	N/A	Painted X Walk2?	N/A
	X Walk 1 Direction	To SE		X Walk 2 Direction	N/A
N/A	X Walk 1 Width (in)	N/A	N/A	X Walk 2 Width (in)	N/A
	X Walk 1 Slope (%)	5.4		X Walk 2 Slope (%)	N/A
	X Walk 1 X Slope (%)	0.5		X Walk 2 X Slope (%)	N/A

N/A	Ramp inside XWalk1?	N/A	N/A	Ramp inside XWalk2?	N/A
	Road Slope (%)	N/A	N/A	Clear Space?	N/A
	Road X Slope (%)	N/A	N/A	Clear Space to XWalk (in)	N/A
N/A	Any Obstructions?	N/A	N/A	Storm Grate/Utility Hazard?	N/A
	Obstruction Type			Storm Grate/Utility Type	
		N/A			N/A
			Yes	Surface Condition? (G/P)	Good

Possible Solutions:

Remove & Replace Entire Ramp.
