# Access Compliance Report

## Public Rights-of-Way

### (Curb Ramps)

Intersection ID: 10025976	Main Street: ELM_LN	Cross Street: N/A	Location: SE
ADA ID: 108E2A43A810	Ramp Type: PerpDiag	Initial Pass/Fail: Fail	Overall Compliance: No
Codes/Mitigation Info/Possible Solution		Field Measurements/Component Compliance	
Severity Score: 12.5

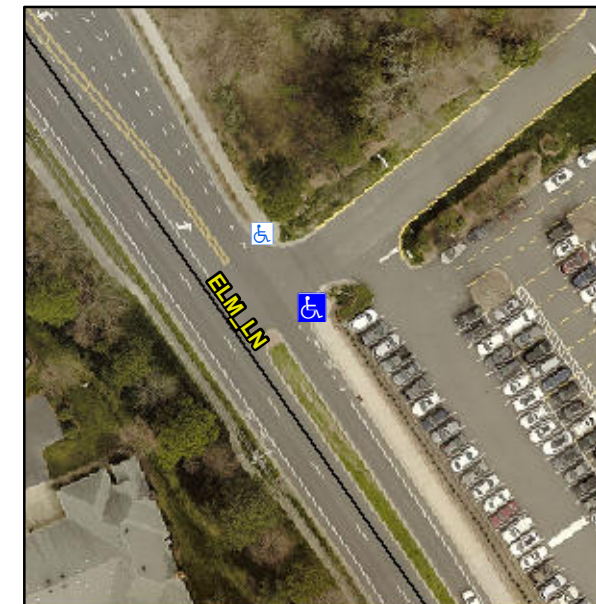
Compliance	Description	Data	Compliance	Description	Data
N/A	Ramp Length (in)	48.0	No	Ramp Slope (%)	8.7
Yes	Ramp Width (in)	48.0	Yes	Ramp XSlope (%)	0.5
N/A	Flare Type LT	N/A	N/A	Flare Type RT	N/A
N/A	Flare Slope LT (%)	N/A	N/A	Flare Slope RT (%)	N/A
N/A	Flare Traversable LT?	N/A	N/A	Flare Traversable RT?	N/A
N/A	Landing Length (in)	N/A	N/A	DWS Provided?	N/A
N/A	Landing Width (in)	N/A	N/A	DWS Contrast?	N/A
N/A	Landing Slope (%)	N/A	N/A	DWS Length (in)	N/A
N/A	Landing X Slope (%)	N/A	N/A	DWS Full Width?	N/A
N/A	Landing Curb? (Y/N)	N/A	N/A	DWS Offset (in)	N/A
N/A	Shared Landing?	N/A			
N/A	Gutter Ponding?	N/A	N/A	Gutter Slope (%)	N/A
N/A	Gutter Lip Ht (in)	N/A	N/A	Gutter X Slope (%)	N/A
N/A	Painted X Walk1?	No	N/A	Painted X Walk2?	No
	X Walk 1 Direction	To NW		X Walk 2 Direction	To SW
N/A	X Walk 1 Width (in)	N/A	N/A	X Walk 2 Width (in)	N/A
	X Walk 1 Slope (%)	0.7		X Walk 2 Slope (%)	0.8
	X Walk 1 X Slope (%)	1.7		X Walk 2 X Slope (%)	0.7

N/A	Ramp inside XWalk1?	N/A	N/A	Ramp inside XWalk2?	N/A
	Road Slope (%)	1.2	N/A	Clear Space?	N/A
	Road X Slope (%)	1.2	N/A	Clear Space to XWalk (in)	N/A
N/A	Any Obstructions?	N/A	N/A	Storm Grate/Utility Hazard?	N/A
	Obstruction Type			Storm Grate/Utility Type	
		N/A			N/A
			Yes	Surface Condition? (G/P)	Good

Possible Solutions:

**Remove & Replace Curb Ramp With Two New Directional Ramps or Equivalent.**

PROW/ADA:

**R304.2.2**
