# Access Compliance Report

## Public Rights-of-Way

### (Curb Ramps)

Intersection ID: 24469	Main Street: MIROW_PL	Cross Street: SAINTFIELD_PL	Location: NW
ADA ID: 1099112B1857	Ramp Type: PerpDiag	Initial Pass/Fail: Fail	Overall Compliance: No
		Severity Score: 30

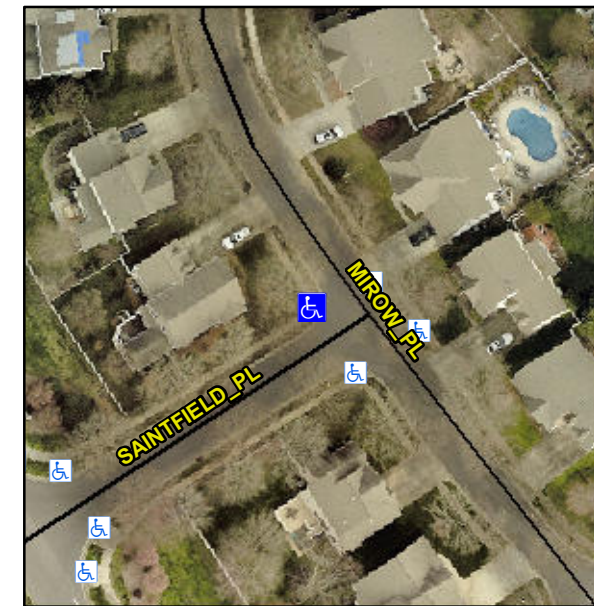
**N/A**

Compliance	Description	Data	Compliance	Description	Data
N/A	Ramp Length (in)	46.0	No	Ramp Slope (%)	10.8
No	Ramp Width (in)	35.0	Yes	Ramp XSlope (%)	1.8
N/A	Flare Type LT	N/A	N/A	Flare Type RT	N/A
N/A	Flare Slope LT (%)	N/A	N/A	Flare Slope RT (%)	N/A
N/A	Flare Traversable LT?	N/A	N/A	Flare Traversable RT?	N/A
N/A	Landing Length (in)	N/A	N/A	DWS Provided?	N/A
N/A	Landing Width (in)	N/A	N/A	DWS Contrast?	N/A
N/A	Landing Slope (%)	N/A	N/A	DWS Length (in)	N/A
N/A	Landing X Slope (%)	N/A	N/A	DWS Full Width?	N/A
N/A	Landing Curb? (Y/N)	N/A	N/A	DWS Offset (in)	N/A
N/A	Shared Landing?	N/A			
N/A	Gutter Ponding?	N/A	N/A	Gutter Slope (%)	N/A
N/A	Gutter Lip Ht (in)	N/A	N/A	Gutter X Slope (%)	N/A
N/A	Painted X Walk1?	No	N/A	Painted X Walk2?	No
	X Walk 1 Direction	To S		X Walk 2 Direction	To E
N/A	X Walk 1 Width (in)	N/A	N/A	X Walk 2 Width (in)	N/A
	X Walk 1 Slope (%)	6.2		X Walk 2 Slope (%)	7.8
	X Walk 1 X Slope (%)	3.3		X Walk 2 X Slope (%)	6.3

N/A	Ramp inside XWalk1?	N/A	N/A	Ramp inside XWalk2?	N/A
	Road Slope (%)	3.8	N/A	Clear Space?	N/A
	Road X Slope (%)	8.8	N/A	Clear Space to XWalk (in)	N/A
N/A	Any Obstructions?	N/A	N/A	Storm Grate/Utility Hazard?	N/A
	Obstruction Type			Storm Grate/Utility Type	
		N/A			N/A
			Yes	Surface Condition? (G/P)	Good

**Remove & Replace Curb Ramp With Two New Directional Ramps or Equivalent.**

**R304.5.1, R304.2.2**

Total Cost: \$ 3200.00
