Access Compliance Report

Public Rights-of-Way

(Curb Ramps)

| Intersection ID: 28607 | Main Street: SAHALEE_LN | Cross Street: TROTTER_RD | Location: NW |

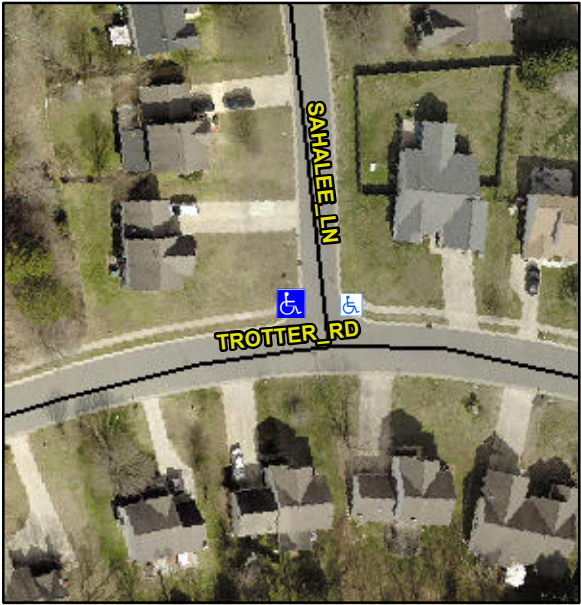
| ADA ID: 109AC2822CCE | Ramp Type: Perp | Initial Pass/Fail: Fail | Overall Compliance: No |

| Codes/Mitigation Info/Possible Solution | | | Field Measurements/Component Compliance | | |
|---|---|--|---|---|---|
| | | | No | Ramp Width (in) | 34.0 |
| <p>Surveyor Notes:</p> <p>N/A</p> <p>PROW/ADA:</p> <p>R304.5.1, R304.5.3</p> | | | N/A | Flare Type RT | N/A |

| Codes/Mitigation Info/Possible Solution | | | Field Measurements/Component Compliance | | |
|---|---|--|---|---|---|
| | Remove & Replace Entire Ramp. | | N/A | Ramp Length (in) | 49.0 |
