Access Compliance Report

Public Rights-of-Way

(Curb Ramps)

Intersection ID: 31910	Main Street: PALOMAR_MOUNTAIN_DR	Cross Street: STOWE_DERBY_DR	Location: NE
ADA ID: 10A731226E5F	Ramp Type: PerpDiag	Initial Pass/Fail: Fail	Overall Compliance: No
Severity Score: 21.25			
Codes/Mitigation Info/Possible Solution		Field Measurements/Component Compliance

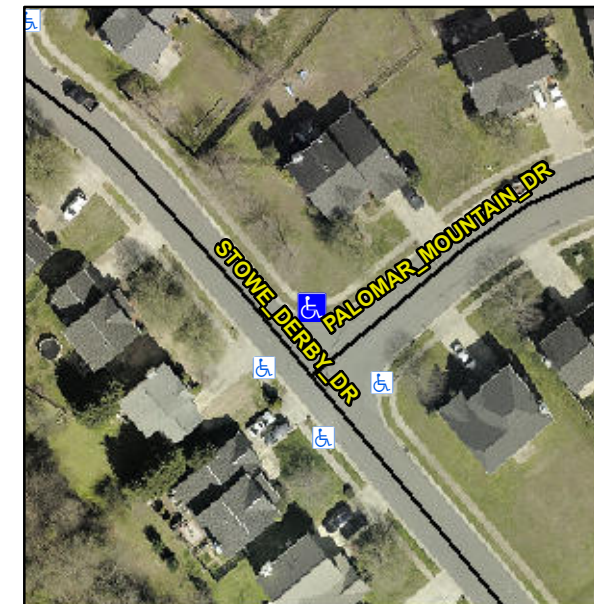
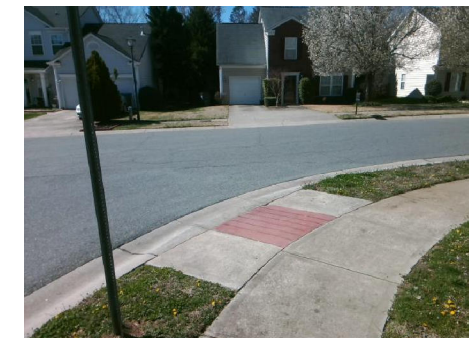
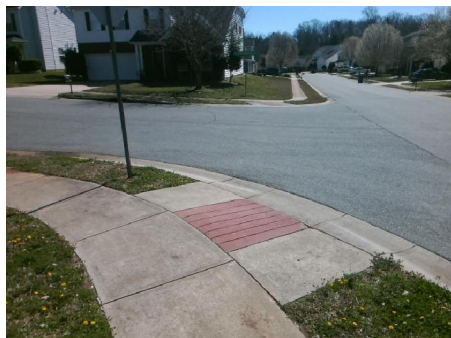
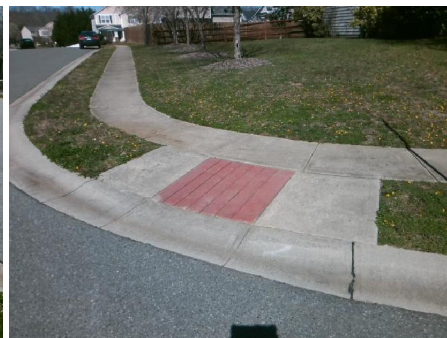
Compliance	Description	Data	Compliance	Description	Data
N/A	Ramp Length (in)	48.0	No	Ramp Slope (%)	9.5
No	Ramp Width (in)	47.0	Yes	Ramp XSlope (%)	0.8
N/A	Flare Type LT	N/A	N/A	Flare Type RT	N/A
N/A	Flare Slope LT (%)	N/A	N/A	Flare Slope RT (%)	N/A
N/A	Flare Traversable LT?	N/A	N/A	Flare Traversable RT?	N/A
N/A	Landing Length (in)	N/A	N/A	DWS Provided?	N/A
N/A	Landing Width (in)	N/A	N/A	DWS Contrast?	N/A
N/A	Landing Slope (%)	N/A	N/A	DWS Length (in)	N/A
N/A	Landing X Slope (%)	N/A	N/A	DWS Full Width?	N/A
N/A	Landing Curb? (Y/N)	N/A	N/A	DWS Offset (in)	N/A
N/A	Shared Landing?	N/A			
N/A	Gutter Ponding?	N/A	N/A	Gutter Slope (%)	N/A
N/A	Gutter Lip Ht (in)	N/A	N/A	Gutter X Slope (%)	N/A
N/A	Painted X Walk1?	No	N/A	Painted X Walk2?	No
	X Walk 1 Direction	To SW		X Walk 2 Direction	To SE
N/A	X Walk 1 Width (in)	N/A	N/A	X Walk 2 Width (in)	N/A
	X Walk 1 Slope (%)	1.8		X Walk 2 Slope (%)	2.8
	X Walk 1 X Slope (%)	2.9		X Walk 2 X Slope (%)	1.9

N/A	Ramp inside XWalk1?	N/A	N/A	Ramp inside XWalk2?	N/A
	Road Slope (%)	0.5	N/A	Clear Space?	N/A
	Road X Slope (%)	6.2	N/A	Clear Space to XWalk (in)	N/A
N/A	Any Obstructions?	N/A	N/A	Storm Grate/Utility Hazard?	N/A
	Obstruction Type			Storm Grate/Utility Type	
		N/A			N/A
		Yes		Surface Condition? (G/P)	Good

Remove & Replace Curb Ramp With Two New Directional Ramps or Equivalent.
