Access Compliance Report

Public Rights-of-Way

(Curb Ramps)

Intersection ID: N/A	Main Street: ORCHID_BRIDGE_RD	Cross Street: N/A	Location: N
ADA ID: 10B33FAA249B	Ramp Type: Perp	Initial Pass/Fail: Fail	Overall Compliance: No
		Severity Score: 12.5

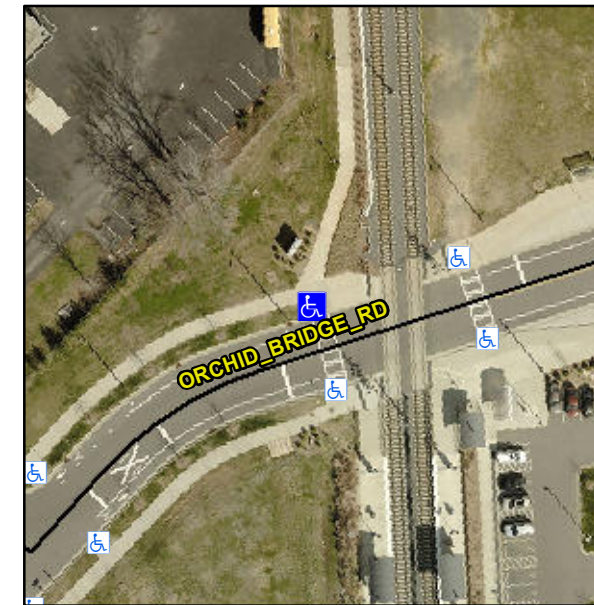
R304.2.2

Compliance	Description	Data	Compliance	Description	Data
N/A	Ramp Length (in)	97.0	No	Ramp Slope (%)	9.5
Yes	Ramp Width (in)	48.0	Yes	Ramp XSlope (%)	1.7
N/A	Flare Type LT	N/A	N/A	Flare Type RT	N/A
N/A	Flare Slope LT (%)	N/A	N/A	Flare Slope RT (%)	N/A
N/A	Flare Traversable LT?	N/A	N/A	Flare Traversable RT?	N/A
N/A	Landing Length (in)	N/A	N/A	DWS Provided?	N/A
N/A	Landing Width (in)	N/A	N/A	DWS Contrast?	N/A
N/A	Landing Slope (%)	N/A	N/A	DWS Length (in)	N/A
N/A	Landing X Slope (%)	N/A	N/A	DWS Full Width?	N/A
N/A	Landing Curb? (Y/N)	N/A	N/A	DWS Offset (in)	N/A
N/A	Shared Landing?	N/A			
N/A	Gutter Ponding?	N/A	N/A	Gutter Slope (%)	N/A
N/A	Gutter Lip Ht (in)	N/A	N/A	Gutter X Slope (%)	N/A
N/A	Painted X Walk1?	Yes	N/A	Painted X Walk2?	N/A
	X Walk 1 Direction	To S		X Walk 2 Direction	N/A
N/A	X Walk 1 Width (in)	104.0	N/A	X Walk 2 Width (in)	N/A
	X Walk 1 Slope (%)	1.5		X Walk 2 Slope (%)	N/A
	X Walk 1 X Slope (%)	1.1		X Walk 2 X Slope (%)	N/A

Remove & Replace Entire Ramp.

\$ 1850.00
