Access Compliance Report

Public Rights-of-Way

(Curb Ramps)

| Intersection ID: 10593 | Main Street: BEATTIES_FORD_RD | Cross Street: ROZZELLES_FERRY_RD | Location: E |

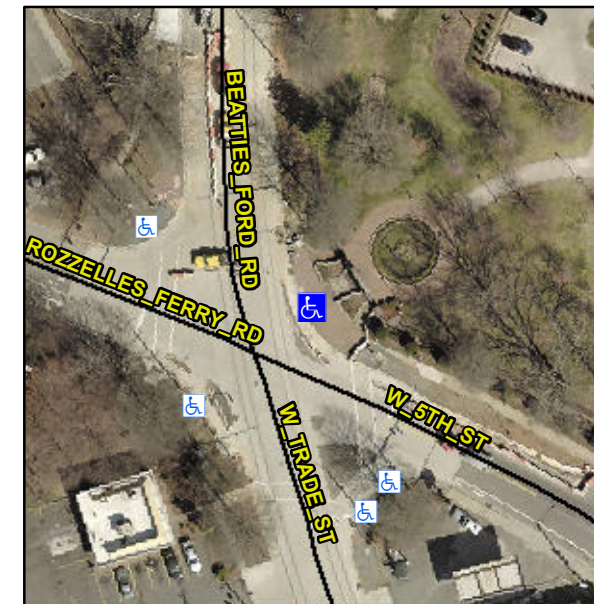
| ADA ID: 10B4D960DFF4 | Ramp Type: PerpDiag | Initial Pass/Fail: Fail | Overall Compliance: No |
| Severity Score: 8.75 | | | |

Not Found, R304.5.1

| Compliance | Description | Data | Compliance | Description | Data |
|---|---|---|---|---|---|
| No | Ramp Width (in) | 39.0 | Yes | Ramp XSlope (%) | 1.7 |
| N/A | Gutter Ponding? | Yes | N/A | Gutter Slope (%) | N/A |

Remove & Replace Curb Ramp With Two New Directional Ramps or Equivalent.

Total Cost: \$ 3200.00
