Access Compliance Report Public Rights-of-Way (Curb Ramps)

Intersection ID: 11313 Main Street: STAFFORD DR Cross Street: WILKINSON_BV Location: SW **Overall Compliance: No** ADA ID: 10B5ED5BC597 Ramp Type: Perp Initial Pass/Fail: Fail **Severity Score:** 12.5

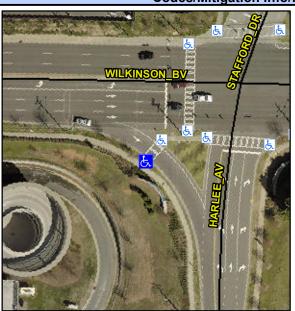
Field Measurements/Component Compliance							
Comp	liance Description	Data	Comp	liance Description	Data		
N/A	Ramp Length (in)	72.0	No	Ramp Slope (%)	8.9		
Yes	Ramp Width (in)	63.0	Yes	Ramp XSlope (%)	0.6		
N/A	Flare Type LT	N/A	N/A	Flare Type RT	N/A		
N/A	Flare Slope LT (%)	N/A	N/A	Flare Slope RT (%)	N/A		
N/A	Flare Traversable LT?	N/A	N/A	Flare Traversable RT?	N/A		
N/A	Landing Length (in)	N/A	N/A	DWS Provided?	N/A		
N/A	Landing Width (in)	N/A	N/A	DWS Contrast?	N/A		
N/A	Landing Slope (%)	N/A	N/A	DWS Length (in)	N/A		
N/A	Landing X Slope (%)	N/A	N/A	DWS Full Width?	N/A		
N/A	Landing Curb? (Y/N)	N/A	N/A	DWS Offset (in)	N/A		
N/A	Shared Landing?	N/A					
N/A	Gutter Ponding?	N/A	N/A	Gutter Slope (%)	N/A		
N/A	Gutter Lip Ht (in)	N/A	N/A	Gutter X Slope (%)	N/A		
N/A	Painted X Walk1?	Yes	N/A	Painted X Walk2?	N/A		
	X Walk 1 Direction	To NE		X Walk 2 Direction	N/A		
N/A	X Walk 1 Width (in)	112.0	N/A	X Walk 2 Width (in)	N/A

X Walk 1 Slope (%)	4.4		X Walk 2 Slope (%)	N/A		
	X Walk 1 X Slope (%)	0.6		X Walk 2 X Slope (%)	N/A		
N/A	Ramp inside XWalk1?	Yes	N/A	Ramp inside XWalk2?	N/A		
	Road Slope (%)	N/A	N/A	Clear Space?	N/A		
	Road X Slope (%)	N/A	N/A	Clear Space to XWalk (in)	N/A		
N/A	Any Obstructions?	N/A	N/A	Storm Grate/Utility Hazard?	N/A		
	Obstruction Type			Storm Grate/Utility Type			
		N/A			N/A		
			Yes	Surface Condition? (G/P)	Good

Possible Solutions:	Con
Remove & Replace Entire Ramp.	N/A
•	Yes
	N/A
	N/A
	N/A
	N/A
Surveyor Notes:	N/A
N/A	N/A
	N/A
	N/A
	N/A
PROW/ADA:	N/A
Not Found, R304.2.2	N/A
·	N/A
	N/A
	N/A

Total Cost:	\$ 1850.00
