Access Compliance Report

Public Rights-of-Way

(Curb Ramps)

Intersection ID: N/A	Main Street: SOLAR_WY	Cross Street: ROCK_ISLAND_RD	Location: NE
ADA ID: 10C6CEBE1CF6	Ramp Type: Perp	Initial Pass/Fail: Fail	Overall Compliance: No
Codes/Mitigation Info/Possible Solution		Field Measurements/Component Compliance	
Severity Score: 12.5

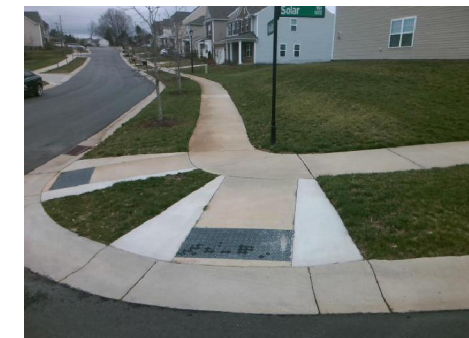
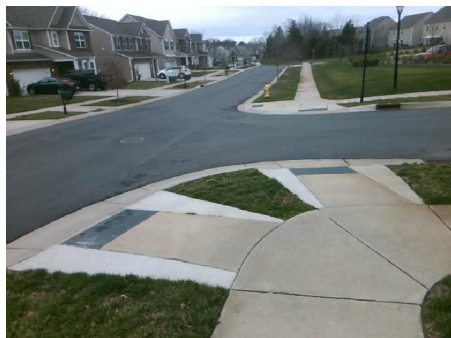
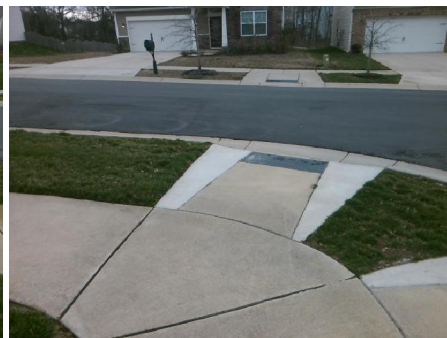
Not Found, R304.5.3

Compliance	Description	Data	Compliance	Description	Data
N/A	Ramp Length (in)	95.0	Yes	Ramp Slope (%)	7.2
Yes	Ramp Width (in)	48.0	No	Ramp XSlope (%)	6.1
N/A	Flare Type LT	N/A	N/A	Flare Type RT	N/A
N/A	Flare Slope LT (%)	N/A	N/A	Flare Slope RT (%)	N/A
N/A	Flare Traversable LT?	N/A	N/A	Flare Traversable RT?	N/A
N/A	Landing Length (in)	N/A	N/A	DWS Provided?	N/A
N/A	Landing Width (in)	N/A	N/A	DWS Contrast?	N/A
N/A	Landing Slope (%)	N/A	N/A	DWS Length (in)	N/A
N/A	Landing X Slope (%)	N/A	N/A	DWS Full Width?	N/A
N/A	Landing Curb? (Y/N)	N/A	N/A	DWS Offset (in)	N/A
N/A	Shared Landing?	N/A			
N/A	Gutter Ponding?	N/A	N/A	Gutter Slope (%)	N/A
N/A	Gutter Lip Ht (in)	N/A	N/A	Gutter X Slope (%)	N/A
N/A	Painted X Walk1?	No	N/A	Painted X Walk2?	N/A
	X Walk 1 Direction	To SE		X Walk 2 Direction	N/A
N/A	X Walk 1 Width (in)	N/A	N/A	X Walk 2 Width (in)	N/A
	X Walk 1 Slope (%)	4.5		X Walk 2 Slope (%)	N/A
	X Walk 1 X Slope (%)	4.7		X Walk 2 X Slope (%)	N/A

N/A	Ramp inside XWalk1?	N/A	N/A	Ramp inside XWalk2?	N/A
	Road Slope (%)	N/A	N/A	Clear Space?	N/A
	Road X Slope (%)	N/A	N/A	Clear Space to XWalk (in)	N/A
N/A	Any Obstructions?	N/A	N/A	Storm Grate/Utility Hazard?	N/A
	Obstruction Type			Storm Grate/Utility Type	
		N/A			N/A
			Yes	Surface Condition? (G/P)	Good

Possible Solutions:

Remove & Replace Entire Ramp.

Total Cost: \$ 1850.00
