Access Compliance Report Public Rights-of-Way (Curb Ramps)

Intersection ID: 32099
 Main Street:
 STEELE_CREEK_RD
 Cross Street:
 ROTHE_HOUSE_RD
 Location:
 SW

ADA ID: 10C7D79DC2AD
 Ramp Type:
 PerpDiag
 Initial Pass/Fail:
 Fail
 Overall Compliance:
 No
 Severity Score:
 25

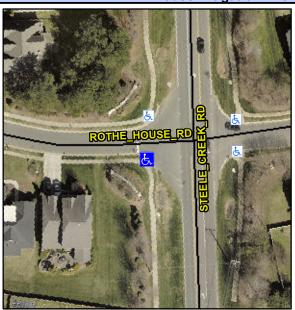
Not Found, R304.2.2

Field Measurements/Component Compilance					
Compliance Description		Data	Compliance Description		Data
N/A	Ramp Length (in)	45.5	No	Ramp Slope (%)	14.6
Yes	Ramp Width (in)	48.0	Yes	Ramp XSlope (%)	0.9
N/A	Flare Type LT	N/A	N/A	Flare Type RT	N/A
N/A	Flare Slope LT (%)	N/A	N/A	Flare Slope RT (%)	N/A
N/A	Flare Traversable LT?	N/A	N/A	Flare Traversable RT?	N/A
N/A	Landing Length (in)	N/A	N/A	DWS Provided?	N/A
N/A	Landing Width (in)	N/A	N/A	DWS Contrast?	N/A
N/A	Landing Slope (%)	N/A	N/A	DWS Length (in)	N/A
N/A	Landing X Slope (%)	N/A	N/A	DWS Full Width?	N/A
N/A	Landing Curb? (Y/N)	N/A	N/A	DWS Offset (in)	N/A
N/A	Shared Landing?	N/A			
N/A	Gutter Ponding?	N/A	N/A	Gutter Slope (%)	N/A
N/A	Gutter Lip Ht (in)	N/A	N/A	Gutter X Slope (%)	N/A
N/A	Painted X Walk1?	No	N/A	Painted X Walk2?	No
	X Walk 1 Direction	То Е		X Walk 2 Direction	To N
N/A	X Walk 1 Width (in)	N/A	N/A	X Walk 2 Width (in)	N/A
	X Walk 1 Slope (%)	1.7		X Walk 2 Slope (%)	3.4

X Walk 1 X Slope (%)	2.2		X Walk 2 X Slope (%)	2.5
N/A	Ramp inside XWalk1?	N/A	N/A	Ramp inside XWalk2?	N/A
	Road Slope (%)	0.5	N/A	Clear Space?	N/A
	Road X Slope (%)	2.4	N/A	Clear Space to XWalk (in)	N/A
N/A	Any Obstructions?	N/A	N/A	Storm Grate/Utility Hazard?	N/A
	Obstruction Type			Storm Grate/Utility Type	
		N/A			N/A
			Yes	Surface Condition? (G/P)	Good

STEELE CREEK RD None ROTHE HOUSE RD StopSign Possible Solutions:

Remove & Replace Curb Ramp With Two New Directional Ramps or Equivalent.
