# Access Compliance Report

## Public Rights-of-Way

### (Curb Ramps)

Intersection ID: 13149	Main Street: CENTRAL_AV	Cross Street: THE_PLAZA	Location: NW
ADA ID: 10CF3654956E	Ramp Type: Perp	Initial Pass/Fail: Fail	Overall Compliance: No
Severity Score: 8.75			
Codes/Mitigation Info/Possible Solution		Field Measurements/Component Compliance

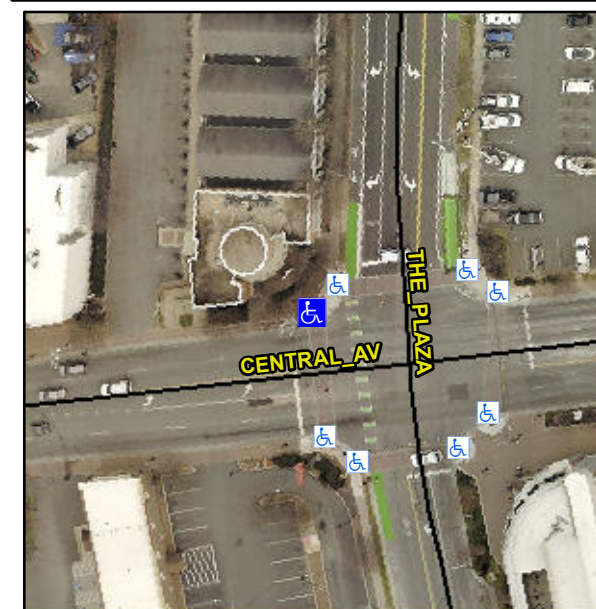
**Not Found, R304.5.1**

Compliance	Description	Data	Compliance	Description	Data
N/A	Ramp Length (in)	74.0	Yes	Ramp Slope (%)	8.0
No	Ramp Width (in)	37.5	Yes	Ramp XSlope (%)	1.0
N/A	Flare Type LT	N/A	N/A	Flare Type RT	N/A
N/A	Flare Slope LT (%)	N/A	N/A	Flare Slope RT (%)	N/A
N/A	Flare Traversable LT?	N/A	N/A	Flare Traversable RT?	N/A
N/A	Landing Length (in)	N/A	N/A	DWS Provided?	N/A
N/A	Landing Width (in)	N/A	N/A	DWS Contrast?	N/A
N/A	Landing Slope (%)	N/A	N/A	DWS Length (in)	N/A
N/A	Landing X Slope (%)	N/A	N/A	DWS Full Width?	N/A
N/A	Landing Curb? (Y/N)	N/A	N/A	DWS Offset (in)	N/A
N/A	Shared Landing?	N/A			
N/A	Gutter Ponding?	N/A	N/A	Gutter Slope (%)	N/A
N/A	Gutter Lip Ht (in)	N/A	N/A	Gutter X Slope (%)	N/A
N/A	Painted X Walk1?	Yes	N/A	Painted X Walk2?	N/A
	X Walk 1 Direction	To S		X Walk 2 Direction	N/A
N/A	X Walk 1 Width (in)	96.0	N/A	X Walk 2 Width (in)	N/A
	X Walk 1 Slope (%)	0.1		X Walk 2 Slope (%)	N/A
	X Walk 1 X Slope (%)	3.4		X Walk 2 X Slope (%)	N/A

N/A	Ramp inside XWalk1?	Yes	N/A	Ramp inside XWalk2?	N/A
	Road Slope (%)	N/A	N/A	Clear Space?	N/A
	Road X Slope (%)	N/A	N/A	Clear Space to XWalk (in)	N/A
N/A	Any Obstructions?	N/A	N/A	Storm Grate/Utility Hazard?	N/A
	Obstruction Type			Storm Grate/Utility Type	
		N/A			N/A
		Yes		Surface Condition? (G/P)	Good

**Remove & Replace Entire Ramp.**
