Access Compliance Report Public Rights-of-Way (Curb Ramps)

Intersection ID: 11796 Main Street: N PINE ST Cross Street: W_6TH_ST Location: W

Overall Compliance: No ADA ID: 10D26A2BB2FB Ramp Type: PerpDiag Initial Pass/Fail: Fail **Severity Score:** 62.5

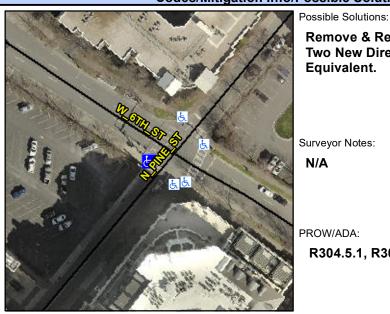
Poor

Compliance Description		Data	Compliance Description		Data
N/A	Ramp Length (in)	86.0	Yes	Ramp Slope (%)	5.4
No	Ramp Width (in)	25.0	No	Ramp XSlope (%)	5.8
N/A	Flare Type LT	N/A	N/A	Flare Type RT	N/A
N/A	Flare Slope LT (%)	N/A	N/A	Flare Slope RT (%)	N/A
N/A	Flare Traversable LT?	N/A	N/A	Flare Traversable RT?	N/A
N/A	Landing Length (in)	N/A	N/A	DWS Provided?	N/A
N/A	Landing Width (in)	N/A	N/A	DWS Contrast?	N/A
N/A	Landing Slope (%)	N/A	N/A	DWS Length (in)	N/A
N/A	Landing X Slope (%)	N/A	N/A	DWS Full Width?	N/A
N/A	Landing Curb? (Y/N)	N/A	N/A	DWS Offset (in)	N/A
N/A	Shared Landing?	N/A			
N/A	Gutter Ponding?	N/A	N/A	Gutter Slope (%)	N/A
N/A	Gutter Lip Ht (in)	N/A	N/A	Gutter X Slope (%)	N/A
N/A	Painted X Walk1?	Yes	N/A	Painted X Walk2?	Yes
	X Walk 1 Direction	To SE		X Walk 2 Direction	To NE
N/A	X Walk 1 Width (in)	84.0	N/A	X Walk 2 Width (in)	108.0
	X Walk 1 Slope (%)	5.5		X Walk 2 Slope (%)	1.3
	X Walk 1 X Slope (%)	1.5		X Walk 2 X Slope (%)	2.4

Remove & Replace Curb Ramp With Two New Directional Ramps or Equivalent.

R304.5.1, R304.5.3, R302.7
