# Access Compliance Report

## Public Rights-of-Way

### (Curb Ramps)

Intersection ID: 50606	Main Street: DENBUR_DR	Cross Street: BENDING_BRANCH_RD	Location: N
ADA ID: 10D4113EC584	Ramp Type: Perp	Initial Pass/Fail: Fail	Overall Compliance: No
Severity Score: 21.25			
Codes/Mitigation Info/Possible Solution		Field Measurements/Component Compliance

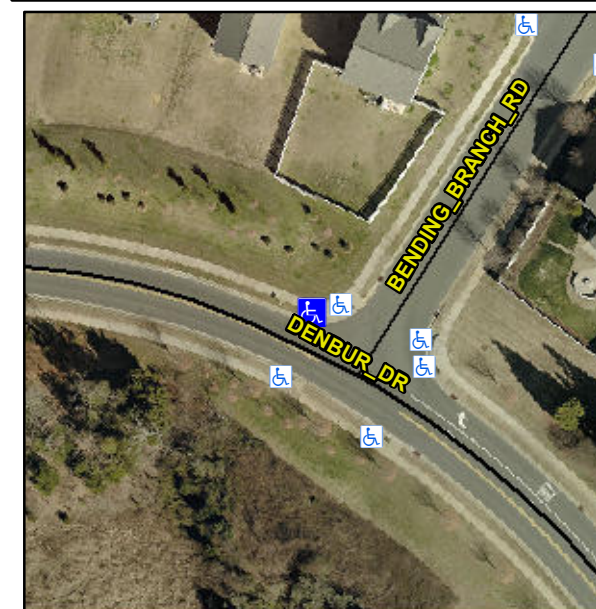
**Not Found, R304.5.1, R304.5.3**

Compliance	Description	Data	Compliance	Description	Data
N/A	Ramp Length (in)	48.0	Yes	Ramp Slope (%)	7.3
No	Ramp Width (in)	46.5	No	Ramp XSlope (%)	6.0
N/A	Flare Type LT	N/A	N/A	Flare Type RT	N/A
N/A	Flare Slope LT (%)	N/A	N/A	Flare Slope RT (%)	N/A
N/A	Flare Traversable LT?	N/A	N/A	Flare Traversable RT?	N/A
N/A	Landing Length (in)	N/A	N/A	DWS Provided?	N/A
N/A	Landing Width (in)	N/A	N/A	DWS Contrast?	N/A
N/A	Landing Slope (%)	N/A	N/A	DWS Length (in)	N/A
N/A	Landing X Slope (%)	N/A	N/A	DWS Full Width?	N/A
N/A	Landing Curb? (Y/N)	N/A	N/A	DWS Offset (in)	N/A
N/A	Shared Landing?	N/A			
N/A	Gutter Ponding?	N/A	N/A	Gutter Slope (%)	N/A
N/A	Gutter Lip Ht (in)	N/A	N/A	Gutter X Slope (%)	N/A
N/A	Painted X Walk1?	No	N/A	Painted X Walk2?	N/A
	X Walk 1 Direction	To SW		X Walk 2 Direction	N/A
N/A	X Walk 1 Width (in)	N/A	N/A	X Walk 2 Width (in)	N/A
	X Walk 1 Slope (%)	1.5		X Walk 2 Slope (%)	N/A
	X Walk 1 X Slope (%)	5.4		X Walk 2 X Slope (%)	N/A

N/A	Ramp inside XWalk1?	N/A	N/A	Ramp inside XWalk2?	N/A
	Road Slope (%)	N/A	N/A	Clear Space?	N/A
	Road X Slope (%)	N/A	N/A	Clear Space to XWalk (in)	N/A
N/A	Any Obstructions?	N/A	N/A	Storm Grate/Utility Hazard?	N/A
	Obstruction Type			Storm Grate/Utility Type	
		N/A			N/A
			Yes	Surface Condition? (G/P)	Good

**Remove & Replace Entire Ramp.**

Total Cost: \$ 1850.00
