Access Compliance Report Public Rights-of-Way (Curb Ramps)

Intersection ID: 13861 Main Street: GANYMEDE_PL Cross Street: HOLLIROSE_DR Location: SW

ADA ID: 10D6F9EEC4B Ramp Type: Directional1 Initial Pass/Fail: Fail Overall Compliance: No Severity Score: 8.75

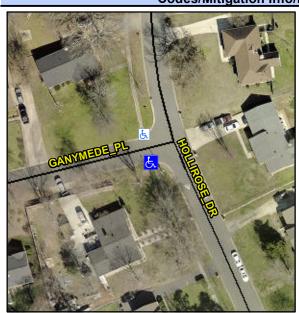
Field Measurements/Component Compliance							
Compli	iance E	Description	Data	Compli	ance	Description	Data
N/A	Ramp L	ength (in)	55.5	N/A	Grade	e Break?	N/A
No	Ramp \	Vidth (in)	47.0	N/A	Grade	e Break Slope (%)	0.0
Yes	Ramp S	Slope (%)	6.5	N/A	Grade	e Break XSlope (%)	0.0
Yes	Ramp >	(Slope (%)	1.7				
N/A	Flare Type LT		N/A	N/A	Flare Type RT		N/A
N/A	Flare Slope LT (%)		N/A	N/A	Flare	Slope RT (%)	0.0
N/A	Flare Traversable LT?		N/A	N/A	Flare Traversable RT?		N/A
N/A	Landing Length (in)		0.0	N/A	DWS	Provided?	N/A
N/A	Landing Width (in)		0.0	N/A	DWS	Contrast?	N/A
N/A	Landing Slope (%)		0.0	N/A	DWS	Length (in)	N/A
N/A	Landing X Slope (%)		0.0	N/A	DWS	Full Width?	N/A
N/A	Landing Curb? (Y/N)		N/A	N/A	DWS	Offset LT (in)	N/A
N/A	Shared Landing?		N/A	N/A	DWS	Offset RT (in)	N/A
N/A	Gutter Ponding?		0.0	N/A	Gutte	r Slope (%)	N/A
N/A	Gutter Lip Ht (in)		0.0	N/A	Gutte	r X Slope (%)	N/A
N/A	Painted	X Walk1?	No		Road	Slope (%)	3.3

X Walk	1 Direction	To N		Road	X Slope (%)	2.2
	X Walk	1 Width (in)	N/A		Clear	Space?	N/A
	X Walk	1 Slope (%)	3.3	N/A	Clear	Space to XWalk (in)	N/A
	X Walk	1 X Slope (%)	2.2	N/A	Storm	Grate/Utility Hazard?	N/A
N/A	Ramp inside XWalk1?		N/A		Storm	Grate/Utility Type	
N/A	Any Ob	structions?	N/A				N/A
	Obstruc	ction Type		Yes	Surfa	ce Condition? (G/P)	Good
			N/A	N/A	Curb	Slope (%)	7.5

Remove & Replace Entire Ramp.
