Access Compliance Report Public Rights-of-Way (Curb Ramps)

Intersection ID: 29336	Main Str	Main Street: NEVIN_BROOK_RD			WHITE_ROCK_CT	Location:	W		
ADA ID: 10E729020268	Ramp Ty	Ramp Type: PerpDiag			Initial Pass/Fail: Fail Overall Compliance: No				37.5
Codes/Mitigation Info/Possible Solution				hitial Pass/Fail: Fail Overall Compliance: No Severity Score: 37.5 Field Measurements/Component Compliance					
		Possible Solutions:						Compliance Description Data	
		Remove & Replace Curb Ram	n With	N/A	Ramp Length (in)	49.0	No	Ramp Slope (%)	8.7
		Two New Directional Ramps	•	Yes	Ramp Width (in)	101.0	No	Ramp XSlope (%)	7.6
		Equivalent.	<i>,</i>	N/A	Flare Type LT	N/A	N/A	Flare Type RT	N/A
				N/A	Flare Slope LT (%)	N/A		Flare Slope RT (%)	N/A

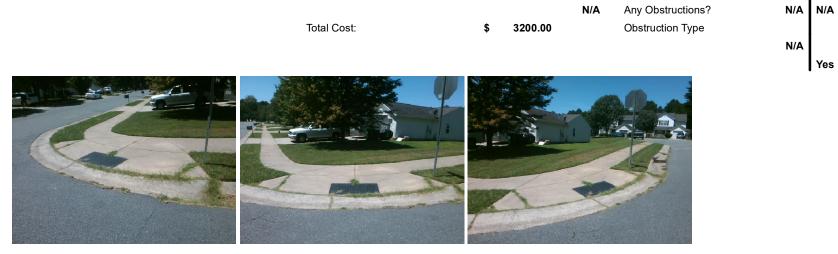
- Marta				N/A	Flare Traversable LT?	N/A		Flare Traversable RT?	N/A
DO				N/A	Landing Length (in)	N/A		DWS Provided?	N/A N/A
the				N/A		N/A	N/A	DWS Contrast?	N/A N/A
					Landing Width (in)				
		N/A		N/A	Landing Slope (%)	N/A		DWS Length (in)	N/A
	A ANERT			N/A	Landing X Slope (%)	N/A	N/A	DWS Full Width?	N/A
				N/A	Landing Curb? (Y/N)	N/A	N/A	DWS Offset (in)	N/A
				N/A	Shared Landing?	N/A			
	A	PROW/ADA:		N/A	Gutter Ponding?	N/A	N/A	Gutter Slope (%)	N/A
Not Found, R304.2.2, R304.5.3			3	N/A	Gutter Lip Ht (in)	N/A	N/A	Gutter X Slope (%)	N/A
				N/A	Painted X Walk1?	No	N/A	Painted X Walk2?	No
					X Walk 1 Direction	To SE		X Walk 2 Direction	To NE
	AND			N/A	X Walk 1 Width (in)	N/A	N/A	X Walk 2 Width (in)	N/A
Street 1 Name	NEVIN BROOK RD	-			X Walk 1 Slope (%)	2.1		X Walk 2 Slope (%)	11.0
Stop Condition-Street 2	None				X Walk 1 X Slope (%)	9.3		X Walk 2 X Slope (%)	5.4
Street 2 Name	WHITE ROCK CT			N/A	Ramp inside XWalk1?	N/A	N/A	Ramp inside XWalk2?	N/A

Stop Condition-Street 1	StopSign				Road Slope (%)	9.1	N/A	Clear Space?	N/A
					Road X Slope (%)	4.7	N/A	Clear Space to XWalk (in)	N/A
				N/A	Any Obstructions?	 N/A	N/A	Storm Grate/Utility Hazard?	N/A
		Total Cost: \$	3200.00	11/2	Obstruction Type	17/4		Storm Grate/Utility Type	17/2
			3200.00		Obstruction Type	N1/A		Storm Grate/Otimity Type	N//A
						N/A			N/A
