# Access Compliance Report

## Public Rights-of-Way

### (Curb Ramps)

| Intersection ID: 7306 | Main Street: CLEARVIEW_DR | Cross Street: DAWNSHIRE_AV | Location: NW |

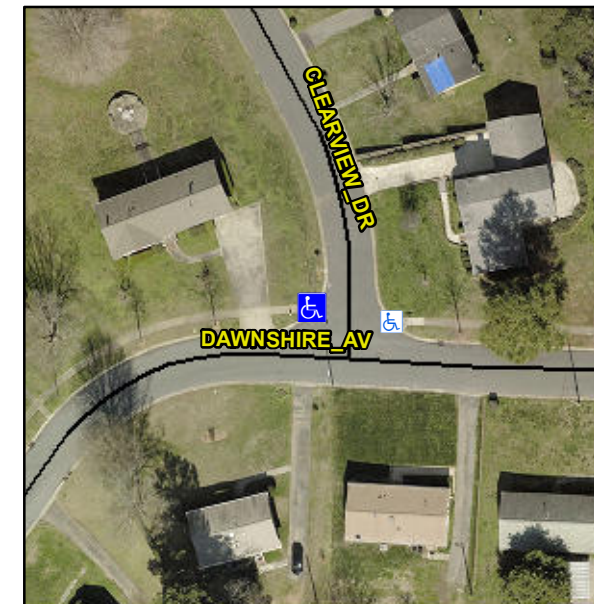
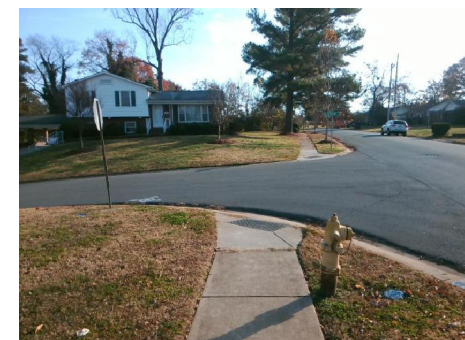
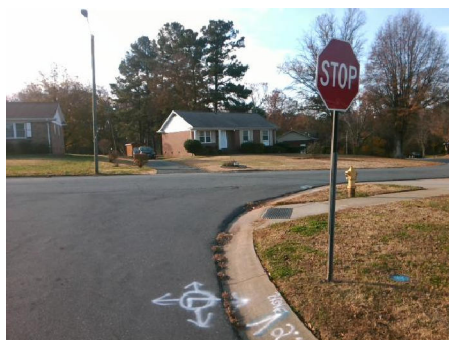
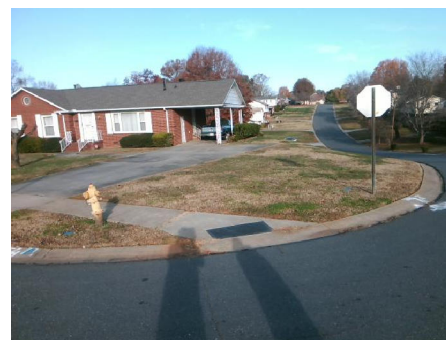
| ADA ID: 10EA65BAB934 | Ramp Type: BlendTrans1 | Initial Pass/Fail: Pass | Overall Compliance: No |
| | | Severity Score: 15 | |

**Not Found, R304.2.1, R305.2, R302.7.2**

| Compliance | Description | Data | Compliance | Description | Data |
|---|---|---|---|---|---|
| No | Landing Width (in) | 47.5 | Yes | DWS Contrast? | Yes |
| N/A | Landing Curb? (Y/N) | No | No | DWS Offset (in) | 3.0 |
| No | Gutter Lip Ht (in) | 4.0 | Yes | Gutter X Slope (%) | 0.7 |
| | | | No | Curb Slope (%) | 10.5 |

**Remove & Replace Curb Ramp With Two New Directional Ramps or Equivalent.**

Total Cost: \$ 3200.00
