Access Compliance Report

Public Rights-of-Way

(Curb Ramps)

Intersection ID: 21035	Main Street: RUSTIC_LN	Cross Street: SHARON_VIEW_RD	Location: SW
ADA ID: 10EC35343DD8	Ramp Type: PerpDiag	Initial Pass/Fail: Fail	Overall Compliance: No
		Severity Score: 10

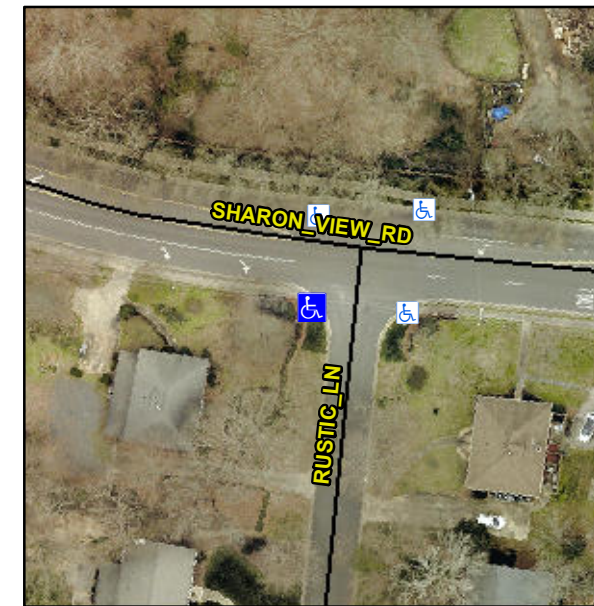
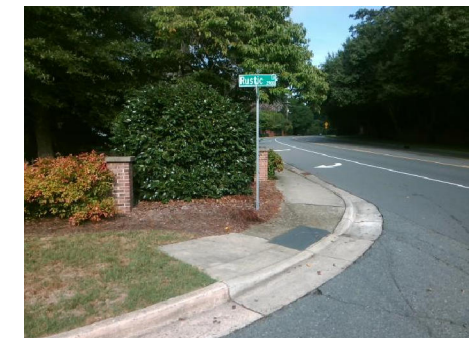
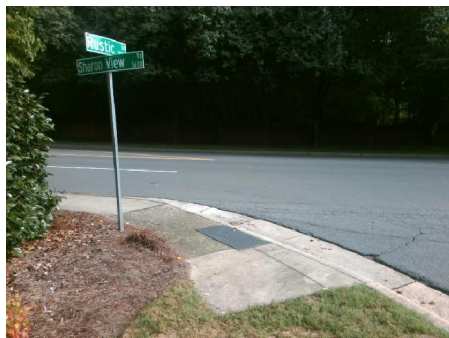
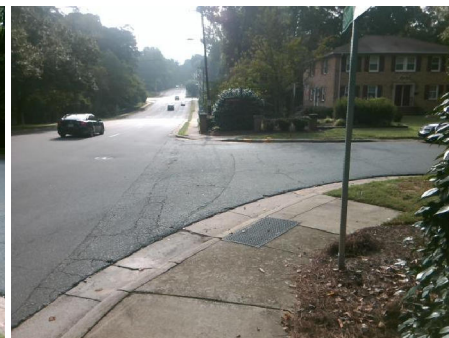
Not Found, R304.5.1, R304.5.3

Compliance	Description	Data	Compliance	Description	Data
N/A	Ramp Length (in)	61.5	Yes	Ramp Slope (%)	6.7
No	Ramp Width (in)	38.0	No	Ramp XSlope (%)	3.6
N/A	Flare Type LT	N/A	N/A	Flare Type RT	N/A
N/A	Flare Slope LT (%)	N/A	N/A	Flare Slope RT (%)	N/A
N/A	Flare Traversable LT?	N/A	N/A	Flare Traversable RT?	N/A
N/A	Landing Length (in)	N/A	N/A	DWS Provided?	N/A
N/A	Landing Width (in)	N/A	N/A	DWS Contrast?	N/A
N/A	Landing Slope (%)	N/A	N/A	DWS Length (in)	N/A
N/A	Landing X Slope (%)	N/A	N/A	DWS Full Width?	N/A
N/A	Landing Curb? (Y/N)	N/A	N/A	DWS Offset (in)	N/A
N/A	Shared Landing?	N/A			
N/A	Gutter Ponding?	N/A	N/A	Gutter Slope (%)	N/A
N/A	Gutter Lip Ht (in)	N/A	N/A	Gutter X Slope (%)	N/A
N/A	Painted X Walk1?	No	N/A	Painted X Walk2?	No
	X Walk 1 Direction	To SE		X Walk 2 Direction	To NE
N/A	X Walk 1 Width (in)	N/A	N/A	X Walk 2 Width (in)	N/A
	X Walk 1 Slope (%)	0.0		X Walk 2 Slope (%)	2.3
	X Walk 1 X Slope (%)	3.9		X Walk 2 X Slope (%)	1.3

N/A	Ramp inside XWalk1?	N/A	N/A	Ramp inside XWalk2?	N/A
	Road Slope (%)	3.8	N/A	Clear Space?	N/A
	Road X Slope (%)	3.9	N/A	Clear Space to XWalk (in)	N/A
N/A	Any Obstructions?	N/A	N/A	Storm Grate/Utility Hazard?	N/A
	Obstruction Type			Storm Grate/Utility Type	
		N/A			N/A
			Yes	Surface Condition? (G/P)	Good

Remove & Replace Curb Ramp With Two New Directional Ramps or Equivalent.
