Access Compliance Report Public Rights-of-Way (Curb Ramps)

Intersection ID: 4064 Main Street: DAVID_COX_RD **Cross Street: MERLOT_LN** Location: NW **Overall Compliance: No Severity Score:** ADA ID: 10EFE6A2F051 Ramp Type: Perp Initial Pass/Fail: Fail 22.5

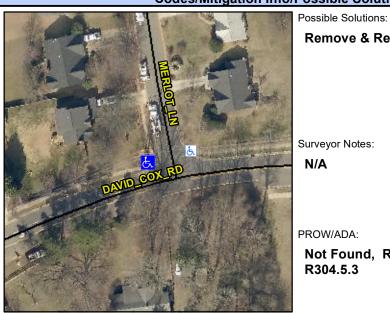
Field Measurements/Component Compliance										
Compl	iance Description	Data	Compli	ance	Description	Data				
N/A	Ramp Length (in)	50.0	No	Ramp	Slope (%)	8.9				
No	Ramp Width (in)	46.0	No Ramp XSlope (%)		XSlope (%)	4.6				
N/A	Flare Type LT	N/A	N/A Flare Type RT		Type RT	N/A				
N/A	Flare Slope LT (%)	N/A	N/A Flare Slope RT (%)		Slope RT (%)	N/A				
N/A	Flare Traversable LT?	N/A	N/A	N/A Flare Traversable RT?		N/A				
N/A	Landing Length (in)	N/A	N/A	DWS	Provided?	N/A				
N/A	Landing Width (in)	N/A	N/A	DWS	Contrast?	N/A				
N/A	Landing Slope (%)	N/A	N/A	DWS	Length (in)	N/A				
N/A	Landing X Slope (%)	N/A	N/A	DWS	Full Width?	N/A				
N/A	Landing Curb? (Y/N)	N/A	N/A	DWS	Offset (in)	N/A				
N/A	Shared Landing?	N/A								
N/A	Gutter Ponding?	N/A	N/A	Gutte	r Slope (%)	N/A				
N/A	Gutter Lip Ht (in)	N/A	N/A	Gutte	r X Slope (%)	N/A				
N/A	Painted X Walk1?	No	N/A	Paint	ed X Walk2?	N/A				
	X Walk 1 Direction	To E		X Wa	lk 2 Direction	N/A

N/A	X Walk 1 Width (in)	N/A	N/A	X Wa	lk 2 Width (in)	N/A				
	X Walk 1 Slope (%)	4.9		X Wa	lk 2 Slope (%)	N/A				
	X Walk 1 X Slope (%)	1.3		X Wa	lk 2 X Slope (%)	N/A				
N/A	Ramp inside XWalk1?	N/A	N/A	Ramp	inside XWalk2?	N/A				
	Road Slope (%)	N/A	N/A	Clear	Space?	N/A				
	Road X Slope (%)	N/A	N/A	Clear	Space to XWalk (in)	N/A				
N/A	Any Obstructions?	N/A	N/A	Storm	n Grate/Utility Hazard?	N/A				
	Obstruction Type			Storm	n Grate/Utility Type					
		N/A				N/A				
			Yes	Surfa	ce Condition? (G/P)	Good				
	MR 2 1 2 10 5 5 6 10 10 10 10 10 10 10 10 10 10 10 10 10

1 Ossible Colditoris.
Remove & Replace Entire Ramp.
Surveyor Notes:
N/A
1071
PROW/ADA:
Not Found, R304.5.1, R304.2.2,
R304.5.3
