# Access Compliance Report

## Public Rights-of-Way

### (Curb Ramps)

| Intersection ID: 24385 | Main Street: BEVERLY_CREST_BV | Cross Street: BECKMORE_PL | Location: SE |

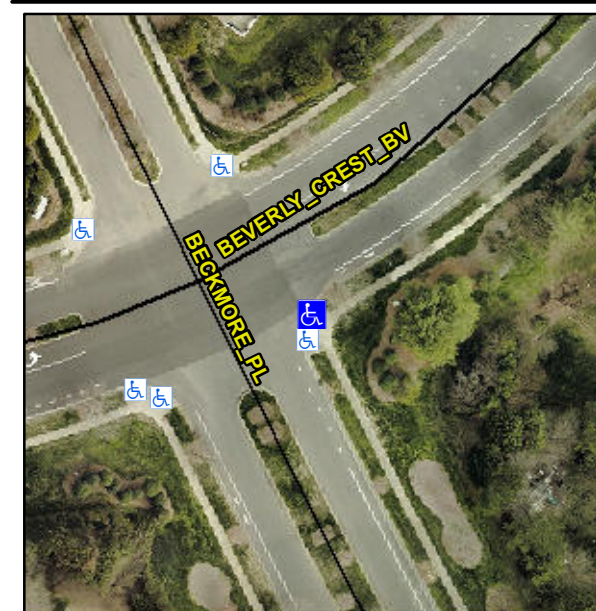
| ADA ID: 10F964F1AED5 | Ramp Type: Perp | Initial Pass/Fail: Fail | Overall Compliance: No |
| Severity Score: 12.5 | | | |

**Not Found, R304.2.2**

| Compliance | Description | Data | Compliance | Description | Data |
|---|---|---|---|---|---|
| N/A | Ramp Length (in) | 96.0 | No | Ramp Slope (%) | 9.0 |

**Remove & Replace Entire Ramp.**

Total Cost: \$ 1850.00

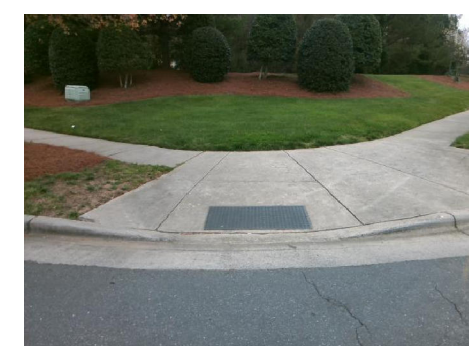
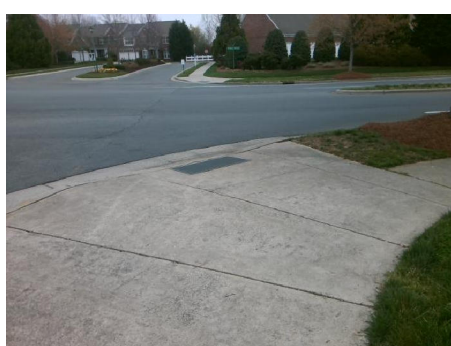
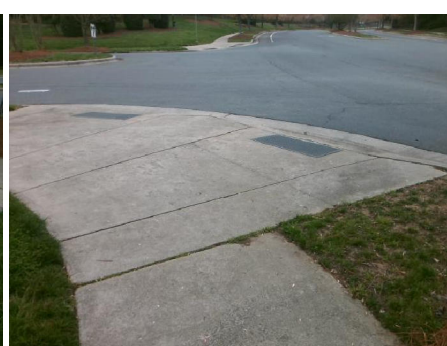
| Compliance | Description | Data | Compliance | Description | Data |
|---|---|---|---|---|---|
| Yes | Ramp Width (in) | 62.0 | Yes | Ramp XSlope (%) | 1.9 |
| | | | Yes | Surface Condition? (G/P) | Good |
