# Access Compliance Report

## Public Rights-of-Way

### (Curb Ramps)

Intersection ID: 9723	Main Street: J JULIAN LN	Cross Street: TUCKASEEGEE_RD	Location:	E
ADA ID: 10FB01AFF3EE	Ramp Type: Perp	Initial Pass/Fail: Fail	Overall Compliance: No	Severity Score: 10

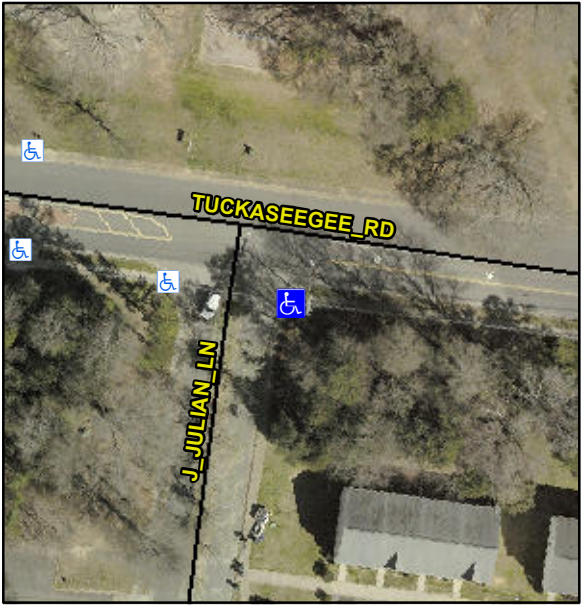
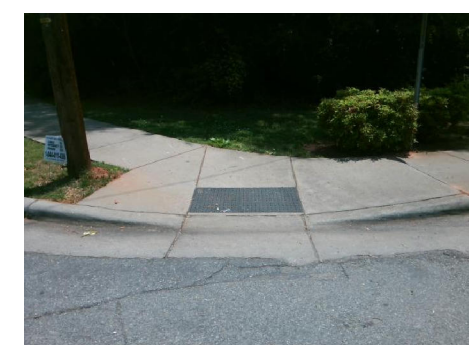
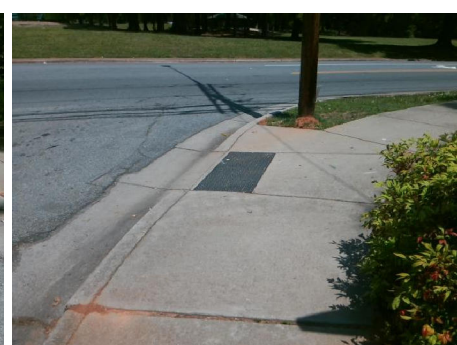
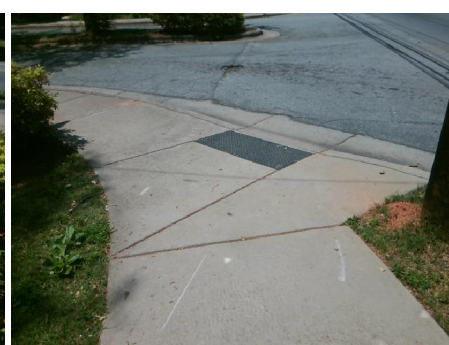
Possible Solutions:		<b>Compliance</b>	<b>Description</b>	<b>Data</b>	
	<b>Remove &amp; Replace Entire Ramp.</b>		<b>N/A</b>	Ramp Length (in)	<b>73.0</b>	<b>Yes</b>
			<b>No</b>	Ramp Width (in)	<b>47.5</b>	<b>No</b>
			<b>N/A</b>	Flare Type LT	<b>N/A</b>	<b>N/A</b>
			<b>N/A</b>	Flare Slope LT (%)	<b>N/A</b>	<b>N/A</b>
			<b>N/A</b>	Flare Traversable LT?	<b>N/A</b>	<b>N/A</b>
			<b>N/A</b>	Landing Length (in)	<b>N/A</b>	<b>N/A</b>
			<b>N/A</b>	Landing Width (in)	<b>N/A</b>	<b>N/A</b>
			<b>N/A</b>	Landing Slope (%)	<b>N/A</b>	<b>N/A</b>
			<b>N/A</b>	Landing X Slope (%)	<b>N/A</b>	<b>N/A</b>
			<b>N/A</b>	Landing Curb? (Y/N)	<b>N/A</b>	<b>N/A</b>
			<b>N/A</b>	Shared Landing?	<b>N/A</b>	
			<b>N/A</b>	Gutter Ponding?	<b>N/A</b>	<b>N/A</b>
			<b>N/A</b>	Gutter Lip Ht (in)	<b>N/A</b>	<b>N/A</b>
			<b>N/A</b>	Painted X Walk1?	<b>No</b>	<b>N/A</b>

X Walk 1 Direction	<b>To W</b>	<b>N/A</b>
			<b>N/A</b>	X Walk 1 Width (in)	<b>N/A</b>	<b>N/A</b>
				X Walk 1 Slope (%)	<b>4.2</b>	<b>N/A</b>
				X Walk 1 X Slope (%)	<b>6.2</b>	<b>N/A</b>
			<b>N/A</b>	Ramp inside XWalk1?	<b>N/A</b>	<b>N/A</b>
<p>Surveyor Notes:</p> <p><b>N/A</b></p> <p>PROW/ADA:</p> <p><b>Not Found, R304.5.1, R304.5.3</b></p>			<b>N/A</b>	Road Slope (%)	<b>N/A</b>	<b>N/A</b>
			<b>N/A</b>	Road X Slope (%)	<b>N/A</b>	<b>N/A</b>
			<b>N/A</b>	Any Obstructions?	<b>N/A</b>	<b>N/A</b>
				Obstruction Type		
					<b>N/A</b>	<b>N/A</b>
			<b>Yes</b>	Surface Condition? (G/P)		<b>Good</b>
Total Cost:		\$ 1850.00
