Access Compliance Report Public Rights-of-Way (Curb Ramps)

Intersection ID: 32277 Main Street: MCALLISTER_PARK_DR Cross Street: PRESCOTT_HILL_AV Location: E

ADA ID: 110B298AAEBC Ramp Type: PerpDiag Initial Pass/Fail: Fail Overall Compliance: No Severity Score: 36.25

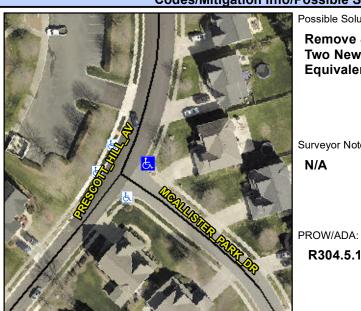
Compliance Description		Data	Comp	liance	Description	Data
N/A	Ramp Length (in)	95.0	Yes	Ramp	Slope (%)	6.3
No	Ramp Width (in)	31.0	No	Ramp	XSlope (%)	4.2
N/A	Flare Type LT	N/A	N/A	Flare	Type RT	N/A
N/A	Flare Slope LT (%)	N/A	N/A	Flare	Slope RT (%)	N/A
N/A	Flare Traversable LT?	N/A	N/A	Flare	Traversable RT?	N/A
N/A	Landing Length (in)	N/A	N/A	DWS	Provided?	N/A
N/A	Landing Width (in)	N/A	N/A	DWS	Contrast?	N/A
N/A	Landing Slope (%)	N/A	N/A	DWS	Length (in)	N/A
N/A	Landing X Slope (%)	N/A	N/A	DWS	Full Width?	N/A
N/A	Landing Curb? (Y/N)	N/A	N/A	DWS	Offset (in)	N/A
N/A	Shared Landing?	N/A				
N/A	Gutter Ponding?	N/A	N/A	Gutte	r Slope (%)	N/A
N/A	Gutter Lip Ht (in)	N/A	N/A	Gutte	r X Slope (%)	N/A
N/A	Painted X Walk1?	No	N/A	Painte	ed X Walk2?	No
	X Walk 1 Direction	To NW		X Wa	lk 2 Direction	To SW
N/A	X Walk 1 Width (in)	N/A	N/A	X Wa	lk 2 Width (in)	N/A
	X Walk 1 Slope (%)	2.6		X Wa	lk 2 Slope (%)	0.1
	X Walk 1 X Slope (%)	1.1		X Wa	lk 2 X Slope (%)	2.6

N/A	Ramp inside XWalk1?	N/A	N/A	Ramp	inside XWalk2?	N/A
	Road Slope (%)	2.8	N/A	Clear	Space?	N/A
	Road X Slope (%)	1.1	N/A	Clear	Space to XWalk (in)	N/A
N/A	Any Obstructions?	N/A	N/A	Storm	Grate/Utility Hazard?	N/A
	Obstruction Type			Storm	Grate/Utility Type	
		N/A				N/A
			Yes	Surfa	ce Condition? (G/P)	Good

Remove & Replace Curb Ramp With
Two New Directional Ramps or
Equivalent.

R304.5.1, R304.5.3
