# Access Compliance Report

## Public Rights-of-Way

| Intersection ID: 30171 | Main Street: BIESTERFIELD_DR | Cross Street: CLIFFROSE_WY | Location: E |
| ADA ID: 111DA8A190FD | Ramp Type: BlendTrans1 | Initial Pass/Fail: Pass | Overall Compliance: No |

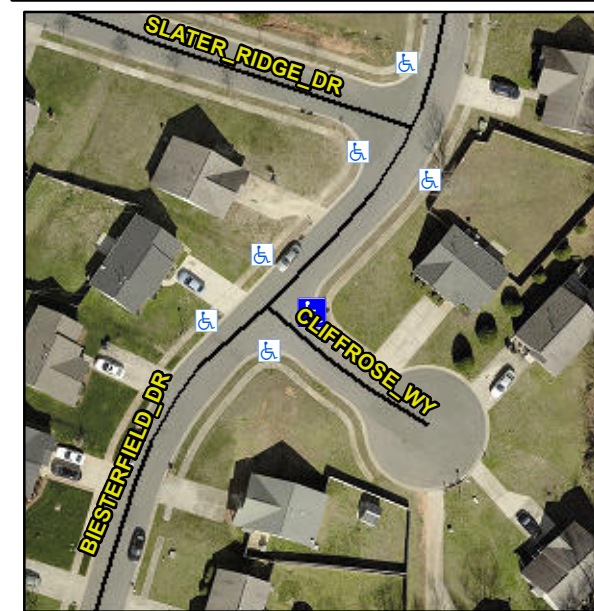
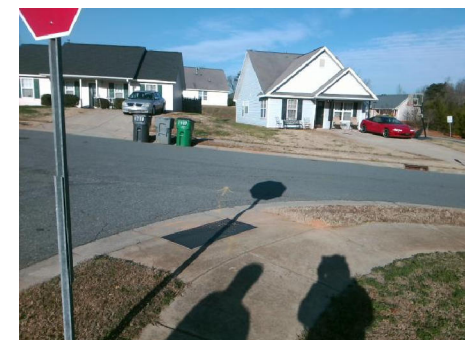
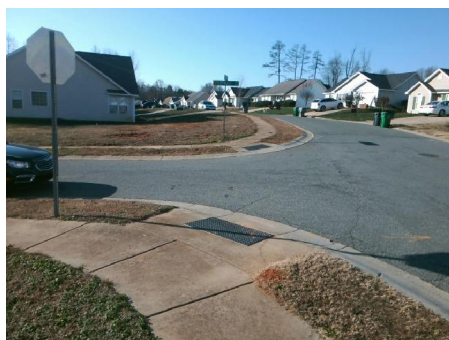
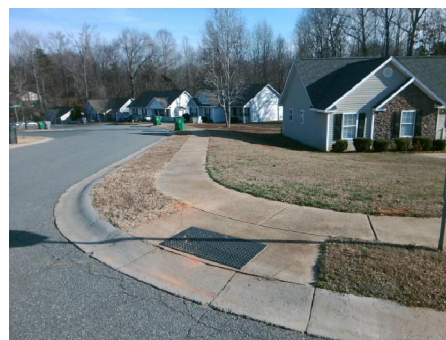
| Severity Score: 5 | | | |

**Not Found, R304.2.1, R304.2.2-Perp, R304.3.2-Para, R305.2, R304.5.4**

| Compliance | Description | Data | Compliance | Description | Data |
|---|---|---|---|---|---|
| No | Landing Length (in) | 47.0 | Yes | DWS Provided? | Yes |
| No | Landing Slope (%) | 2.3 | Yes | DWS Length (in) | 25.5 |
| N/A | Landing Curb? (Y/N) | No | No | DWS Offset (in) | 2.5 |
| Yes | Gutter Ponding? | No | No | Gutter Slope (%) | 9.2 |
| | | | No | Curb Slope (%) | 11.3 |

**Remove & Replace Curb Ramp With Two New Directional Ramps or Equivalent. Remove & Replace Gutter.**

Total Cost: \$ 3950.00
