# Access Compliance Report

## Public Rights-of-Way

### (Curb Ramps)

| Intersection ID: 27680 | Main Street: LANCASTER_HY | Cross Street: BALLANTYNE_COMMONS_PY | Location: SE |

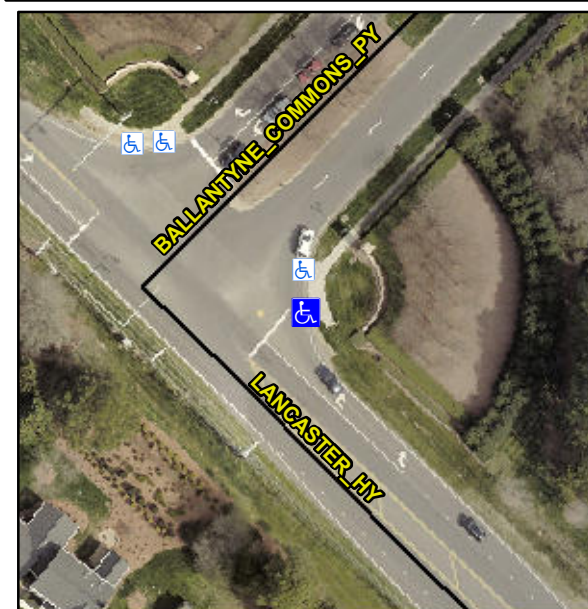
**Not Found, R304.5.1, R304.5.3**

| Compliance | Description | Data | Compliance | Description | Data |
|---|---|---|---|---|---|
| N/A | Ramp Length (in) | 48.0 | Yes | Ramp Slope (%) | 6.8 |
| No | Ramp Width (in) | 47.0 | No | Ramp XSlope (%) | 3.8 |

**Remove & Replace Entire Ramp.**
