Access Compliance Report

Public Rights-of-Way

(Curb Ramps)

Intersection ID: N/A	Main Street: ELMSTONE_DR	Cross Street: THORNHILL CLUB_DR	Location: NE
ADA ID: 115E1F72F190	Ramp Type: Perp	Initial Pass/Fail: Fail	Overall Compliance: No
Severity Score: 33.75			
Codes/Mitigation Info/Possible Solution		Field Measurements/Component Compliance

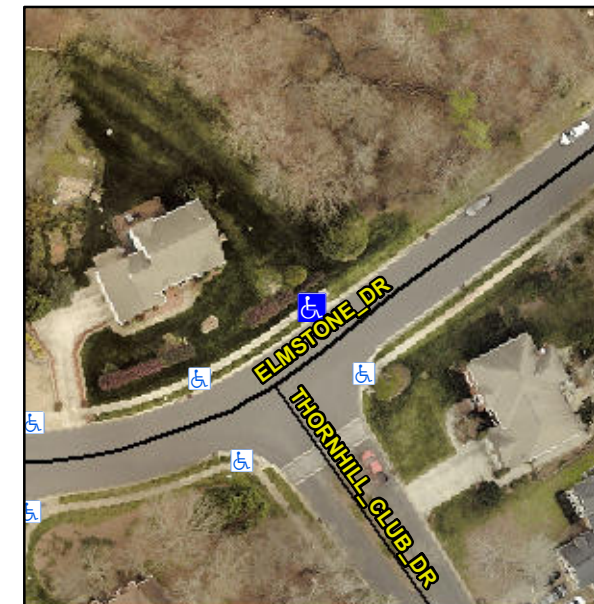
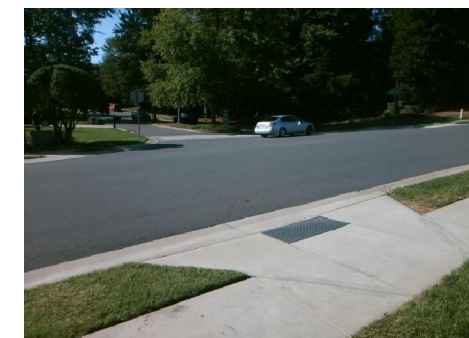
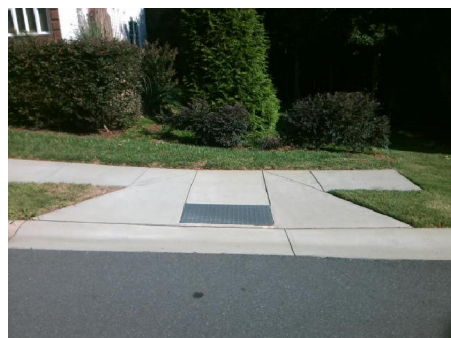
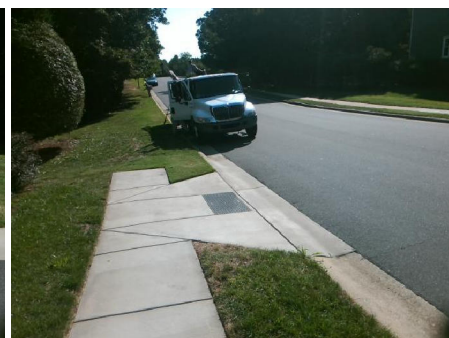
R304.5.1, R304.2.2, R304.5.3

Compliance	Description	Data	Compliance	Description	Data
N/A	Ramp Length (in)	92.0	No	Ramp Slope (%)	8.8
No	Ramp Width (in)	47.5	No	Ramp XSlope (%)	5.1
N/A	Flare Type LT	N/A	N/A	Flare Type RT	N/A
N/A	Flare Slope LT (%)	N/A	N/A	Flare Slope RT (%)	N/A
N/A	Flare Traversable LT?	N/A	N/A	Flare Traversable RT?	N/A
N/A	Landing Length (in)	N/A	N/A	DWS Provided?	N/A
N/A	Landing Width (in)	N/A	N/A	DWS Contrast?	N/A
N/A	Landing Slope (%)	N/A	N/A	DWS Length (in)	N/A
N/A	Landing X Slope (%)	N/A	N/A	DWS Full Width?	N/A
N/A	Landing Curb? (Y/N)	N/A	N/A	DWS Offset (in)	N/A
N/A	Shared Landing?	N/A			
N/A	Gutter Ponding?	N/A	N/A	Gutter Slope (%)	N/A
N/A	Gutter Lip Ht (in)	N/A	N/A	Gutter X Slope (%)	N/A
N/A	Painted X Walk1?	No	N/A	Painted X Walk2?	N/A
	X Walk 1 Direction	To SE		X Walk 2 Direction	N/A
N/A	X Walk 1 Width (in)	N/A	N/A	X Walk 2 Width (in)	N/A
	X Walk 1 Slope (%)	2.1		X Walk 2 Slope (%)	N/A
	X Walk 1 X Slope (%)	4.9		X Walk 2 X Slope (%)	N/A

N/A	Ramp inside XWalk1?	N/A	N/A	Ramp inside XWalk2?	N/A
	Road Slope (%)	N/A	N/A	Clear Space?	N/A
	Road X Slope (%)	N/A	N/A	Clear Space to XWalk (in)	N/A
N/A	Any Obstructions?	N/A	N/A	Storm Grate/Utility Hazard?	N/A
	Obstruction Type			Storm Grate/Utility Type	
		N/A			N/A
			Yes	Surface Condition? (G/P)	Good

Possible Solutions:

Remove & Replace Entire Ramp.
