Access Compliance Report Public Rights-of-Way (Curb Ramps)

Main Street: SOUTHGROVE ST Cross Street: WAVERLY WALK AV Intersection ID: N/A Location: SW **Overall Compliance: No Severity Score:** 10 ADA ID: 1161E9297073 Ramp Type: Perp Initial Pass/Fail: Fail

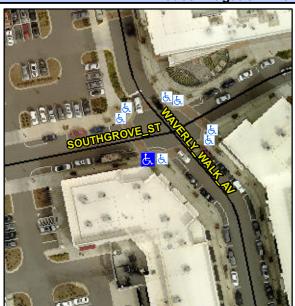
Total Cost: 1850.00 Compliance Description Data Compliance Description Data Yes N/A Ramp Length (in) 65.0 Ramp Slope (%) 6.9 No Ramp XSlope (%) No Ramp Width (in) 47.5 2.6 N/A N/A Flare Type LT N/A Flare Type RT N/A N/A Flare Slope LT (%) N/A N/A Flare Slope RT (%) N/A N/A Flare Traversable LT? N/A N/A Flare Traversable RT? N/A N/A Landing Length (in) N/A N/A **DWS Provided?** N/A N/A Landing Width (in) N/A N/A **DWS Contrast?** N/A N/A N/A N/A Landing Slope (%) DWS Length (in) N/A N/A Landing X Slope (%) N/A N/A DWS Full Width? N/A N/A Landing Curb? (Y/N) N/A N/A DWS Offset (in) N/A N/A N/A Shared Landing? N/A **Gutter Ponding?** N/A N/A Gutter Slope (%) N/A N/A Gutter Lip Ht (in) 1.5 N/A Gutter X Slope (%) N/A N/A Painted X Walk1? Yes N/A Painted X Walk2? N/A X Walk 1 Direction To N X Walk 2 Direction N/A N/A X Walk 1 Width (in) 104.0 X Walk 2 Width (in) N/A X Walk 1 Slope (%) 0.8 X Walk 2 Slope (%) N/A X Walk 2 X Slope (%) X Walk 1 X Slope (%) 1.5 N/A N/A Ramp inside XWalk1? N/A Ramp inside XWalk2? Yes N/A Road Slope (%) N/A N/A Clear Space? N/A N/A Road X Slope (%) N/A Clear Space to XWalk (in) N/A Any Obstructions? N/A N/A N/A Storm Grate/Utility Hazard? N/A **Obstruction Type** Storm Grate/Utility Type N/A N/A

Possible Solutions:
Remove & Replace Entire Ramp.
Surveyor Notes:
N/A
PROW/ADA:
Not Found, R304.5.1, R304.5.3
110t 1 0dild, 11004.0.1, 11004.0.0
