Access Compliance Report

Public Rights-of-Way

(Curb Ramps)

Intersection ID: 27570	Main Street: ALTON_FARM_LN	Cross Street: DEER RIDGE_LN	Location: E
ADA ID: 116242AF4F9A	Ramp Type: Perp	Initial Pass/Fail: Fail	Overall Compliance: No
Severity Score: 21.25			
Codes/Mitigation Info/Possible Solution		Field Measurements/Component Compliance

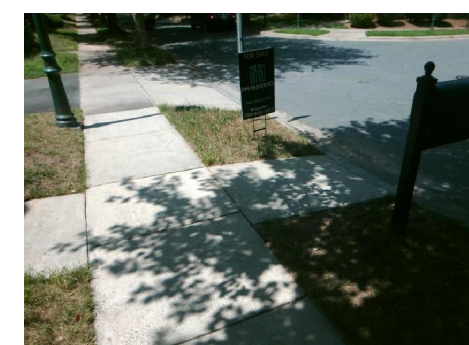
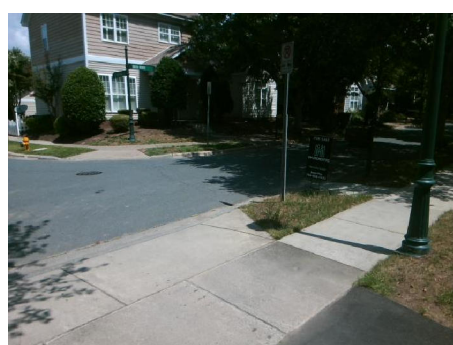
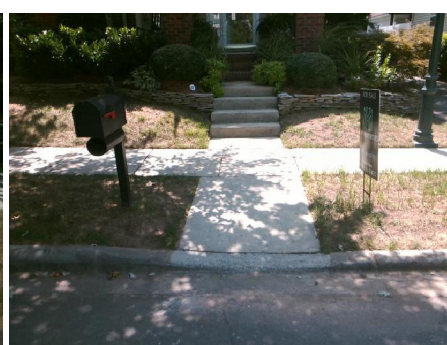
Compliance	Description	Data	Compliance	Description	Data
N/A	Ramp Length (in)	60.0	No	Ramp Slope (%)	11.8
No	Ramp Width (in)	47.5	Yes	Ramp XSlope (%)	1.1
N/A	Flare Type LT	N/A	N/A	Flare Type RT	N/A
N/A	Flare Slope LT (%)	N/A	N/A	Flare Slope RT (%)	N/A
N/A	Flare Traversable LT?	N/A	N/A	Flare Traversable RT?	N/A
N/A	Landing Length (in)	N/A	N/A	DWS Provided?	N/A
N/A	Landing Width (in)	N/A	N/A	DWS Contrast?	N/A
N/A	Landing Slope (%)	N/A	N/A	DWS Length (in)	N/A
N/A	Landing X Slope (%)	N/A	N/A	DWS Full Width?	N/A
N/A	Landing Curb? (Y/N)	N/A	N/A	DWS Offset (in)	N/A
N/A	Shared Landing?	N/A			
N/A	Gutter Ponding?	N/A	N/A	Gutter Slope (%)	N/A
N/A	Gutter Lip Ht (in)	N/A	N/A	Gutter X Slope (%)	N/A
N/A	Painted X Walk1?	No	N/A	Painted X Walk2?	N/A
	X Walk 1 Direction	To NW		X Walk 2 Direction	N/A
N/A	X Walk 1 Width (in)	N/A	N/A	X Walk 2 Width (in)	N/A
	X Walk 1 Slope (%)	2.1		X Walk 2 Slope (%)	N/A
	X Walk 1 X Slope (%)	2.3		X Walk 2 X Slope (%)	N/A

N/A	Ramp inside XWalk1?	N/A	N/A	Ramp inside XWalk2?	N/A
	Road Slope (%)	N/A	N/A	Clear Space?	N/A
	Road X Slope (%)	N/A	N/A	Clear Space to XWalk (in)	N/A
N/A	Any Obstructions?	N/A	N/A	Storm Grate/Utility Hazard?	N/A
	Obstruction Type			Storm Grate/Utility Type	
		N/A			N/A
			Yes	Surface Condition? (G/P)	Good

Possible Solutions:

Remove & Replace Entire Ramp.
