# Access Compliance Report

## Public Rights-of-Way

### (Curb Ramps)

Intersection ID: 11841	Main Street: E_18TH_ST	Cross Street: HARRILL_ST	Location: W
ADA ID: 1164C0AFA02A	Ramp Type: Directional1	Initial Pass/Fail: Fail	Overall Compliance: No
Severity Score: 12.5			
Codes/Mitigation Info/Possible Solution		Field Measurements/Component Compliance

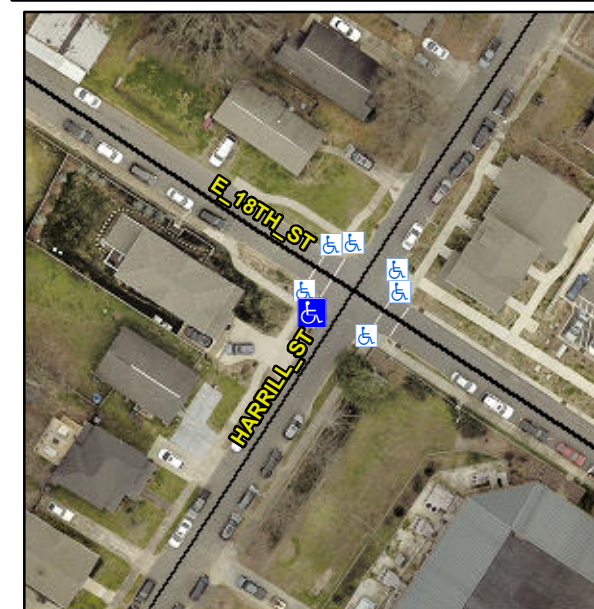
Compliance	Description	Data	Compliance	Description	Data
N/A	Ramp Length (in)	76.0	N/A	Grade Break?	N/A
Yes	Ramp Width (in)	58.0	N/A	Grade Break Slope (%)	0.0
No	Ramp Slope (%)	8.4	N/A	Grade Break XSlope (%)	0.0
Yes	Ramp XSlope (%)	0.7			
N/A	Flare Type LT	N/A	N/A	Flare Type RT	N/A
N/A	Flare Slope LT (%)	N/A	N/A	Flare Slope RT (%)	0.0
N/A	Flare Traversable LT?	N/A	N/A	Flare Traversable RT?	N/A
N/A	Landing Length (in)	0.0	N/A	DWS Provided?	N/A
N/A	Landing Width (in)	0.0	N/A	DWS Contrast?	N/A
N/A	Landing Slope (%)	0.0	N/A	DWS Length (in)	N/A
N/A	Landing X Slope (%)	0.0	N/A	DWS Full Width?	N/A
N/A	Landing Curb? (Y/N)	N/A	N/A	DWS Offset LT (in)	N/A
N/A	Shared Landing?	N/A	N/A	DWS Offset RT (in)	N/A
N/A	Gutter Ponding?	Yes	N/A	Gutter Slope (%)	N/A
N/A	Gutter Lip Ht (in)	0.0	N/A	Gutter X Slope (%)	N/A
N/A	Painted X Walk1?	No		Road Slope (%)	6.0
	X Walk 1 Direction	To SE		Road X Slope (%)	0.5
	X Walk 1 Width (in)	N/A		Clear Space?	N/A

X Walk 1 Slope (%)	6.0	N/A	Clear Space to XWalk (in)	N/A
	X Walk 1 X Slope (%)	0.5	N/A	Storm Grate/Utility Hazard?	N/A
N/A	Ramp inside XWalk1?	N/A		Storm Grate/Utility Type	
N/A	Any Obstructions?	N/A			N/A
	Obstruction Type		Yes	Surface Condition? (G/P)	Good
			N/A	Curb Slope (%)	12.1

**Remove & Replace Entire Ramp.**

**R304.2.2**

\$ 1600.00
