Access Compliance Report

Public Rights-of-Way

(Curb Ramps)

Intersection ID: 49382	Main Street: SOUTH_DEVON_ST	Cross Street: ROCKY_RIVER_RD	Location: SE
ADA ID: 11819645D025	Ramp Type: Perp	Initial Pass/Fail: Fail	Overall Compliance: No
Severity Score: 8.75			
Codes/Mitigation Info/Possible Solution		Field Measurements/Component Compliance

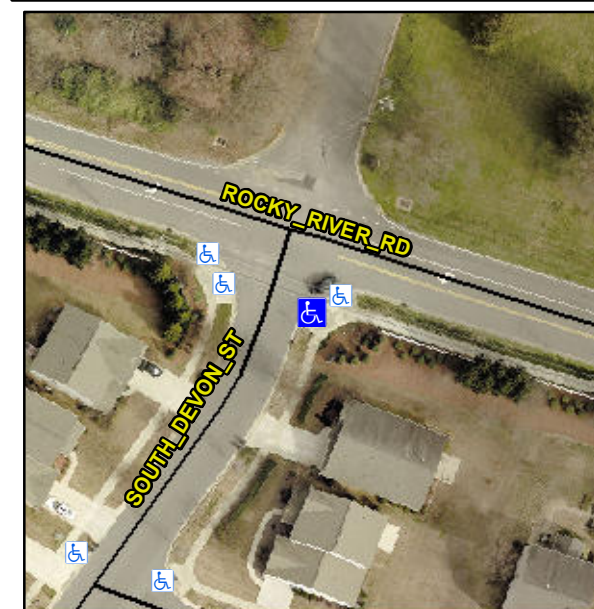
Not Found, R304.5.1

Compliance	Description	Data	Compliance	Description	Data
N/A	Ramp Length (in)	101.5	Yes	Ramp Slope (%)	6.0
No	Ramp Width (in)	47.0	Yes	Ramp XSlope (%)	0.6
N/A	Flare Type LT	N/A	N/A	Flare Type RT	N/A
N/A	Flare Slope LT (%)	N/A	N/A	Flare Slope RT (%)	N/A
N/A	Flare Traversable LT?	N/A	N/A	Flare Traversable RT?	N/A
N/A	Landing Length (in)	N/A	N/A	DWS Provided?	N/A
N/A	Landing Width (in)	N/A	N/A	DWS Contrast?	N/A
N/A	Landing Slope (%)	N/A	N/A	DWS Length (in)	N/A
N/A	Landing X Slope (%)	N/A	N/A	DWS Full Width?	N/A
N/A	Landing Curb? (Y/N)	N/A	N/A	DWS Offset (in)	N/A
N/A	Shared Landing?	N/A			
N/A	Gutter Ponding?	N/A	N/A	Gutter Slope (%)	N/A
N/A	Gutter Lip Ht (in)	N/A	N/A	Gutter X Slope (%)	N/A
N/A	Painted X Walk1?	No	N/A	Painted X Walk2?	N/A
	X Walk 1 Direction	To NW		X Walk 2 Direction	N/A
N/A	X Walk 1 Width (in)	N/A	N/A	X Walk 2 Width (in)	N/A
	X Walk 1 Slope (%)	0.6		X Walk 2 Slope (%)	N/A
	X Walk 1 X Slope (%)	0.6		X Walk 2 X Slope (%)	N/A

N/A	Ramp inside XWalk1?	N/A	N/A	Ramp inside XWalk2?	N/A
	Road Slope (%)	N/A	N/A	Clear Space?	N/A
	Road X Slope (%)	N/A	N/A	Clear Space to XWalk (in)	N/A
N/A	Any Obstructions?	N/A	N/A	Storm Grate/Utility Hazard?	N/A
	Obstruction Type			Storm Grate/Utility Type	
		N/A			N/A
			Yes	Surface Condition? (G/P)	Good

Remove & Replace Entire Ramp.

Total Cost: \$ 1850.00
