Intersection ID: 10011423	Main Street: JEFF_ST	Cross Street: N/A	Location:	W
ADA ID: 118DA9CDEAA9	Ramp Type: Para	Initial Pass/Fail: Fail	Overall Compliance: No	Severity Score: 26.25

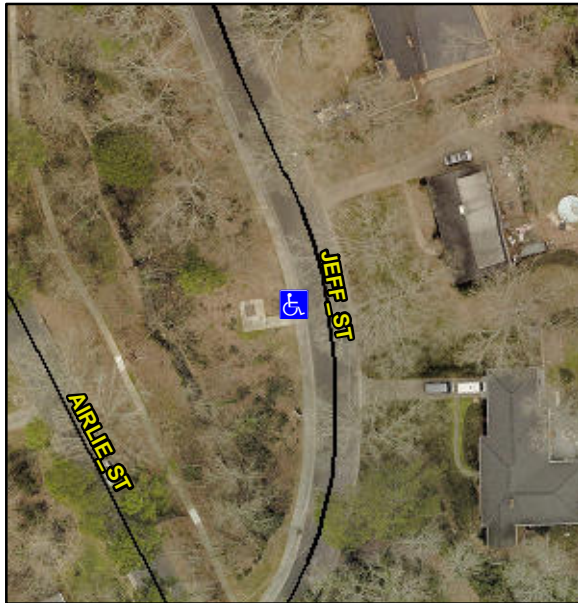
R304.5.3, R304.3.2

Compliance	Description	Data	Compliance	Description	Data
N/A	Ramp Length LT (in)	89.0	N/A	Ramp Length RT (in)	77.0
Yes	Ramp Width LT (in)	48.0	Yes	Ramp Width RT (in)	48.0
Yes	Ramp Slope LT (%)	5.5	No	Ramp Slope RT (%)	14.1
No	Ramp XSlope LT (%)	2.2	No	Ramp XSlope RT (%)	2.8
N/A	Landing Length (in)	N/A	N/A	DWS Provided?	N/A
N/A	Landing Width (in)	N/A	N/A	DWS Contrast?	N/A
N/A	Landing Slope (%)	N/A	N/A	DWS Length (in)	N/A
N/A	Landing X Slope (%)	N/A	N/A	DWS Full Width?	N/A
N/A	Landing Curb? (Y/N)	N/A	N/A	DWS Offset (in)	N/A
N/A	Shared Landing?	N/A			
N/A	Gutter Ponding?	N/A	N/A	Gutter Slope (%)	N/A
N/A	Gutter Lip Ht (in)	N/A	N/A	Gutter X Slope (%)	N/A
N/A	Painted X Walk1?	No	N/A	Painted X Walk2?	N/A
	X Walk 1 Direction	To E		X Walk 2 Direction	N/A
N/A	X Walk 1 Width (in)	N/A	N/A	X Walk 2 Width (in)	N/A
	X Walk 1 Slope (%)	3.0		X Walk 2 Slope (%)	N/A
	X Walk 1 X Slope (%)	3.3		X Walk 2 X Slope (%)	N/A
N/A	Ramp inside XWalk1?	N/A	N/A	Ramp inside XWalk2?	N/A

Remove & Replace Entire Ramp.

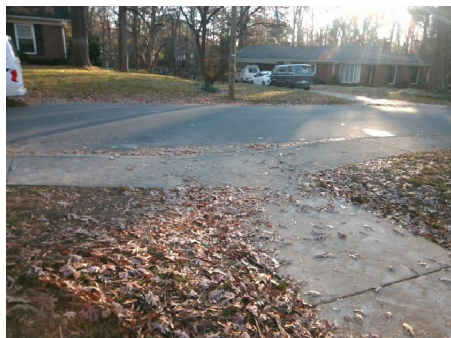
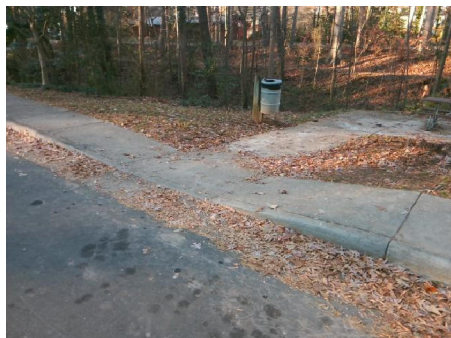
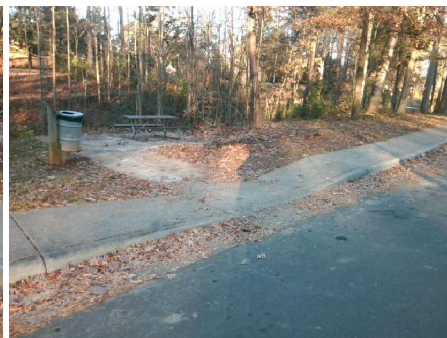
Road Slope (%)	N/A	N/A	Clear Space?	N/A
	Road X Slope (%)	N/A	N/A	Clear Space to XWalk (in)	N/A
N/A	Any Obstructions?	N/A	N/A	Storm Grate/Utility Hazard?	N/A
	Obstruction Type			Storm Grate/Utility Type	
		N/A			N/A
			Yes	Surface Condition? (G/P)	Good
			N/A	Curb Slope (%)	2.2
