# Access Compliance Report

## Public Rights-of-Way

### (Curb Ramps)

Intersection ID: 3928	Main Street: BICKHAM_LN	Cross Street: KIRKGARD_TL	Location: SW
ADA ID: 119C69004148	Ramp Type: Directional1	Initial Pass/Fail: Fail	Overall Compliance: No
			Severity Score: 21.25

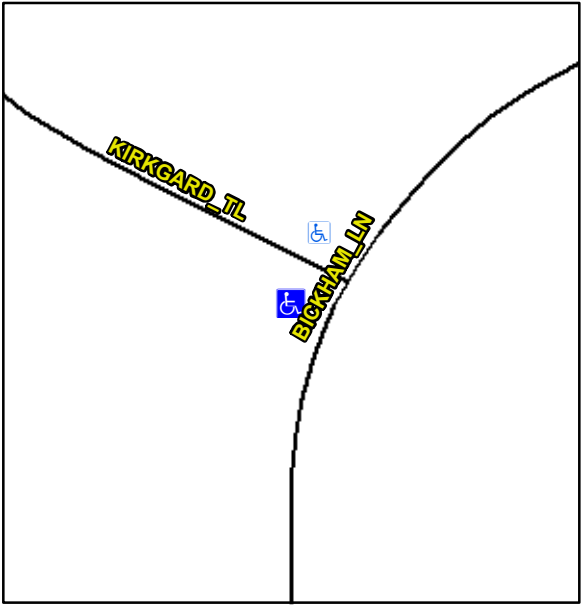
Possible Solutions:		<b>Compliance</b>	<b>Description</b>	<b>Data</b>
	<b>Remove &amp; Replace Entire Ramp.</b>		<b>Compliance</b>	<b>Description</b>	<b>Data</b>
<p>Surveyor Notes:</p> <p><b>N/A</b></p> <p>PROW/ADA:</p> <p><b>R304.5.1, R304.2.2</b></p>			<b>N/A</b>	Ramp Length (in)	<b>63.0</b>
			<b>No</b>	Ramp Width (in)	<b>44.0</b>
			<b>No</b>	Ramp Slope (%)	<b>11.1</b>
			<b>Yes</b>	Ramp XSlope (%)	<b>0.9</b>
			<b>N/A</b>	Flare Type LT	<b>N/A</b>
			<b>N/A</b>	Flare Slope LT (%)	<b>N/A</b>
			<b>N/A</b>	Flare Traversable LT?	<b>N/A</b>
			<b>N/A</b>	Landing Length (in)	<b>0.0</b>
			<b>N/A</b>	Landing Width (in)	<b>0.0</b>
			<b>N/A</b>	Landing Slope (%)	<b>0.0</b>
			<b>N/A</b>	Landing X Slope (%)	<b>0.0</b>
			<b>N/A</b>	Landing Curb? (Y/N)	<b>N/A</b>
			<b>N/A</b>	Shared Landing?	<b>N/A</b>
			<b>N/A</b>	Gutter Ponding?	<b>0.0</b>

<b>N/A</b>	Gutter Lip Ht (in)	<b>0.0</b>
			<b>N/A</b>	Painted X Walk1?	<b>No</b>
				X Walk 1 Direction	<b>To N</b>
				X Walk 1 Width (in)	<b>N/A</b>
				X Walk 1 Slope (%)	<b>3.7</b>
				X Walk 1 X Slope (%)	<b>4.9</b>
			<b>N/A</b>	Ramp inside XWalk1?	<b>N/A</b>
			<b>N/A</b>	Any Obstructions?	<b>N/A</b>
				Obstruction Type	
			<b>Yes</b>	Surface Condition? (G/P)	<b>Good</b>
			<b>N/A</b>	Curb Slope (%)	<b>9.1</b>
Street 1 Name	KIRKGARD TL				
Stop Condition-Street 1	StopSign				
Street 2 Name	N/A				
Stop Condition-Street 2	N/A				
Total Cost:	\$	1600.00
