Access Compliance Report

Public Rights-of-Way

(Curb Ramps)

Intersection ID: 14600	Main Street: DILWORTH_RD	Cross Street: DILWORTH_RD_EAST	Location: W
ADA ID: 11AF21F20F03	Ramp Type: Perp	Initial Pass/Fail: Fail	Overall Compliance: No
		Severity Score: 12.5

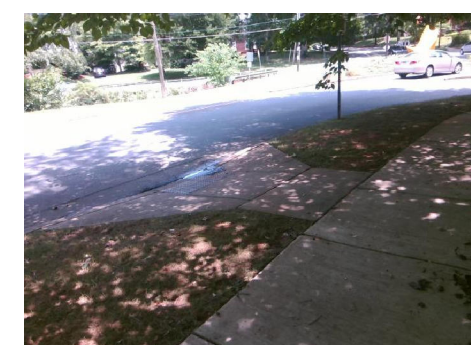
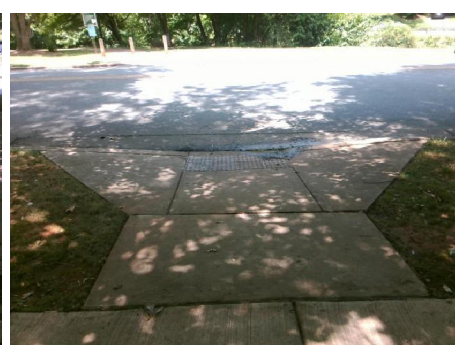
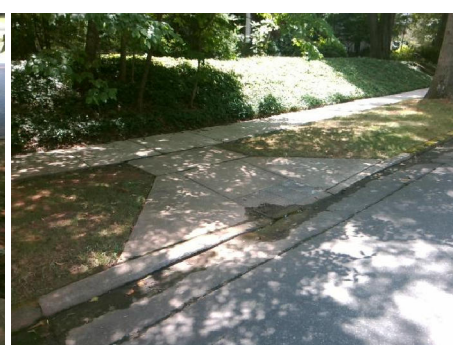
Possible Solutions:	Remove & Replace Entire Ramp.					
	Surveyor Notes:	N/A					
	PROW/ADA:	Not Found, R304.2.2					
	Street 1 Name	DILWORTH RD WEST					
	Stop Condition-Street 2	None					
	Street 2 Name	N/A					
	Stop Condition-Street 1	N/A					
	Total Cost:	\$ 1850.00					
		Compliance	Description	Data	Compliance	Description	Data
		N/A	Ramp Length (in)	112.0	No	Ramp Slope (%)	8.7
		Yes	Ramp Width (in)	48.0	Yes	Ramp XSlope (%)	2.0
		N/A	Flare Type LT	N/A	N/A	Flare Type RT	N/A
		N/A	Flare Slope LT (%)	N/A	N/A	Flare Slope RT (%)	N/A
		N/A	Flare Traversable LT?	N/A	N/A	Flare Traversable RT?	N/A
		N/A	Landing Length (in)	N/A	N/A	DWS Provided?	N/A
		N/A	Landing Width (in)	N/A	N/A	DWS Contrast?	N/A
		N/A	Landing Slope (%)	N/A	N/A	DWS Length (in)	N/A
		N/A	Landing X Slope (%)	N/A	N/A	DWS Full Width?	N/A
		N/A	Landing Curb? (Y/N)	N/A	N/A	DWS Offset (in)	N/A

N/A	Shared Landing?	N/A			
		N/A	Gutter Ponding?	Yes	N/A	Gutter Slope (%)	N/A
		N/A	Gutter Lip Ht (in)	N/A	N/A	Gutter X Slope (%)	N/A
		N/A	Painted X Walk1?	No	N/A	Painted X Walk2?	N/A
			X Walk 1 Direction	To N		X Walk 2 Direction	N/A
		N/A	X Walk 1 Width (in)	N/A	N/A	X Walk 2 Width (in)	N/A
			X Walk 1 Slope (%)	8.0		X Walk 2 Slope (%)	N/A
			X Walk 1 X Slope (%)	3.5		X Walk 2 X Slope (%)	N/A
		N/A	Ramp inside XWalk1?	N/A	N/A	Ramp inside XWalk2?	N/A
			Road Slope (%)	N/A	N/A	Clear Space?	N/A
			Road X Slope (%)	N/A	N/A	Clear Space to XWalk (in)	N/A
		N/A	Any Obstructions?	N/A	N/A	Storm Grate/Utility Hazard?	N/A
			Obstruction Type			Storm Grate/Utility Type	
				N/A			N/A
					Yes	Surface Condition? (G/P)	Good
