Access Compliance Report

Public Rights-of-Way

(Curb Ramps)

Intersection ID: 30498	Main Street: BEDDINGFIELD_DR	Cross Street: ORCHARD GRASS_CT	Location: NE
ADA ID: 11B88812C271	Ramp Type: PerpDiag	Initial Pass/Fail: Fail	Overall Compliance: No
		Severity Score: 10

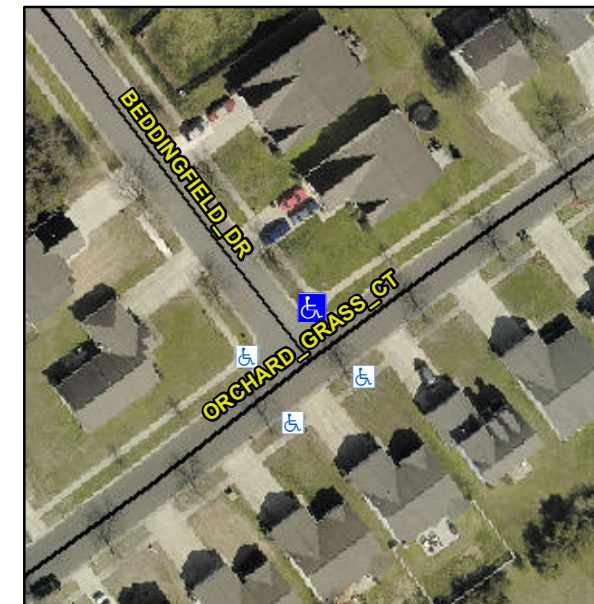
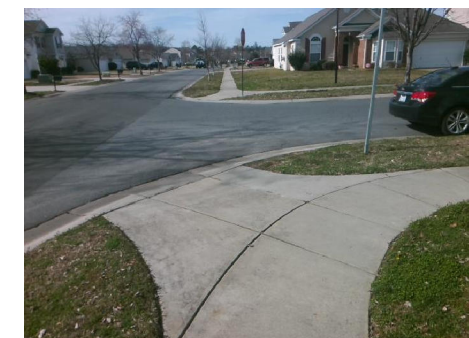
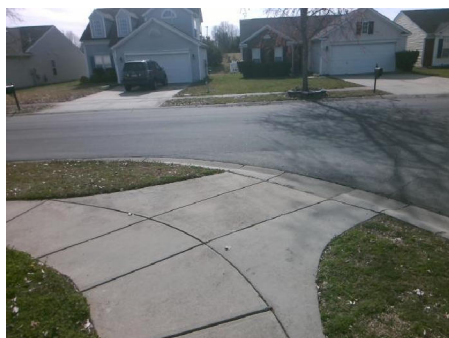
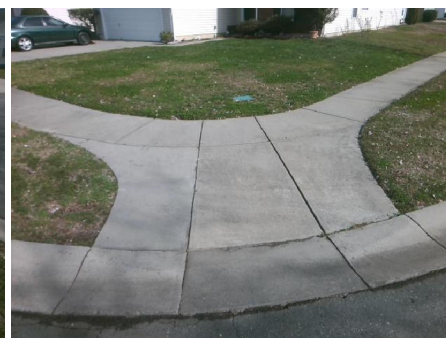
Compliance	Description	Data	Compliance	Description	Data
N/A	Ramp Length (in)	84.0	Yes	Ramp Slope (%)	7.7
No	Ramp Width (in)	38.0	No	Ramp XSlope (%)	2.5
N/A	Flare Type LT	N/A	N/A	Flare Type RT	N/A
N/A	Flare Slope LT (%)	N/A	N/A	Flare Slope RT (%)	N/A
N/A	Flare Traversable LT?	N/A	N/A	Flare Traversable RT?	N/A
N/A	Landing Length (in)	N/A	N/A	DWS Provided?	N/A
N/A	Landing Width (in)	N/A	N/A	DWS Contrast?	N/A
N/A	Landing Slope (%)	N/A	N/A	DWS Length (in)	N/A
N/A	Landing X Slope (%)	N/A	N/A	DWS Full Width?	N/A
N/A	Landing Curb? (Y/N)	N/A	N/A	DWS Offset (in)	N/A
N/A	Shared Landing?	N/A			
N/A	Gutter Ponding?	N/A	N/A	Gutter Slope (%)	N/A
N/A	Gutter Lip Ht (in)	N/A	N/A	Gutter X Slope (%)	N/A
N/A	Painted X Walk1?	No	N/A	Painted X Walk2?	No
	X Walk 1 Direction	To SW		X Walk 2 Direction	To SE
N/A	X Walk 1 Width (in)	N/A	N/A	X Walk 2 Width (in)	N/A
	X Walk 1 Slope (%)	1.4		X Walk 2 Slope (%)	2.4
	X Walk 1 X Slope (%)	0.8		X Walk 2 X Slope (%)	0.3

N/A	Ramp inside XWalk1?	N/A	N/A	Ramp inside XWalk2?	N/A
	Road Slope (%)	0.3	N/A	Clear Space?	N/A
	Road X Slope (%)	2.2	N/A	Clear Space to XWalk (in)	N/A
N/A	Any Obstructions?	N/A	N/A	Storm Grate/Utility Hazard?	N/A
	Obstruction Type			Storm Grate/Utility Type	
		N/A			N/A
			Yes	Surface Condition? (G/P)	Good

Remove & Replace Curb Ramp With Two New Directional Ramps or Equivalent.

R304.5.1, R304.5.3
