Access Compliance Report

Public Rights-of-Way

| Intersection ID: 25988 | Main Street: BLUE_HERON_DR | Cross Street: NIGHTINGALE_LN | Location: SW |
| ADA ID: 11BFA24AA1BC | Ramp Type: Directional1 | Initial Pass/Fail: Fail | Overall Compliance: No |

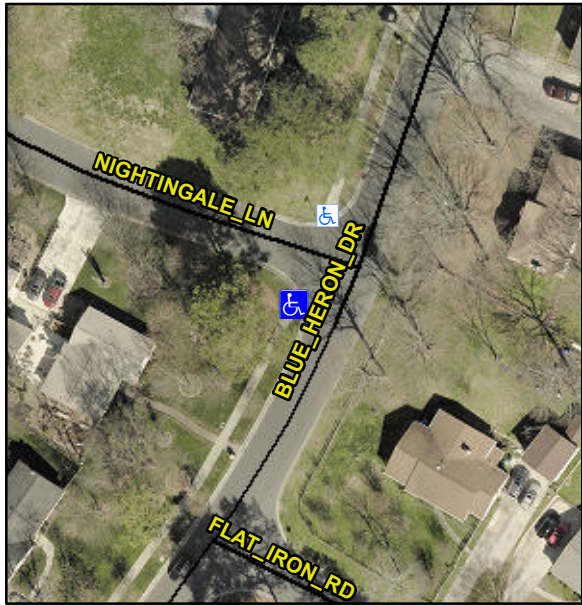
| Severity Score: 1.25 | | | |

R304.5.3

| Compliance | Description | Data | Compliance | Description | Data |
|---|---|---|---|---|---|
| No | Ramp XSlope (%) | 3.7 | | | |

Remove & Replace Entire Ramp.

1600.00
