## Access Compliance Report Public Rights-of-Way (Curb Ramps)

Intersection ID: 47018	Main Str	eet: CARTESIAN_DR	Cross Street: TRIBUNE_DR			Location:	N	
ADA ID: 11C7B767412F	Ramp Ty	/pe: Perp	Initial Pass/Fail: Fail Overall Compliance:			nce: N	o Severity Score:	10
Codes/Mitigation Info/Possible Solution			Field Measurements/Component Compliance					
		Possible Solutions:	Compliance Description		tion Data	Data Compliance Description		Data
		Remove & Replace Entire Ramp	. N/A	Ramp Length (	(in) <b>46.0</b>	Yes	Ramp Slope (%)	7.0

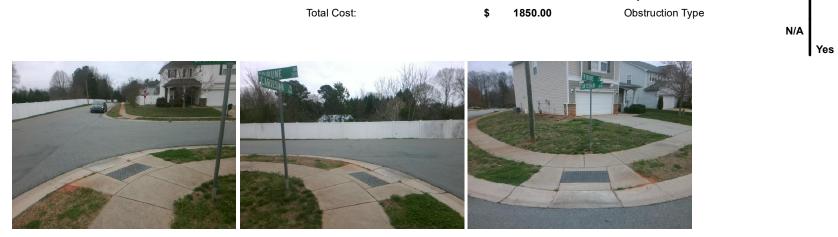
S. S. Alter		No	Ramp Width (ii	n) <b>46.5</b>	No	Ramp XSlope (%)	2.4
	A I A GUL		N/A	Flare Type LT	N/A	N/A	Flare Type RT	N/A
	1 prine the		N/A	Flare Slope LT	- (%) N/A	N/A	Flare Slope RT (%)	N/A
	1/2: 00		N/A	Flare Traversa	ble LT? N/A	N/A	Flare Traversable RT?	N/A
	m 10		N/A	Landing Lengt	h (in) <b>N/A</b>	N/A	DWS Provided?	N/A
hes hes	SAL	Surveyor Notes:	N/A	Landing Width	(in) <b>N/A</b>	N/A	DWS Contrast?	N/A
LA B		N/A	N/A	Landing Slope	(%) N/A	N/A	DWS Length (in)	N/A
	Arx 1		N/A	Landing X Slop	be (%) N/A	N/A	DWS Full Width?	N/A
